COUNCIL MEETING

Subject: Petitions - Fig Tree at 28-30 Edward Street, Bondi

Tree Report

28-30 Edward St, Bondi

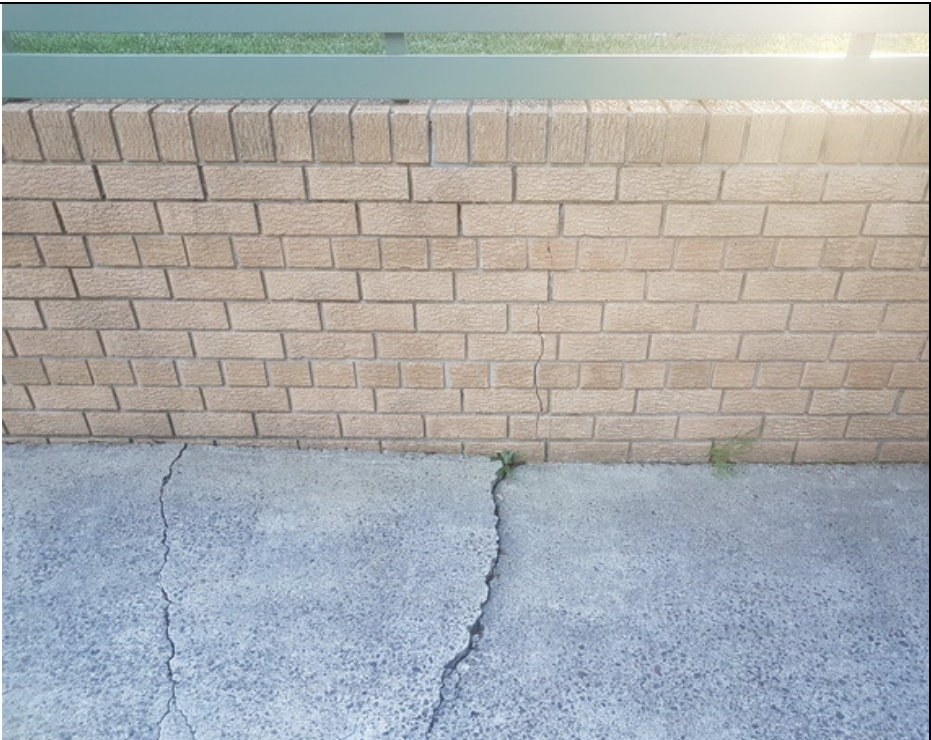
A close-up photograph showing a concrete retaining wall made of light-colored bricks. Below the wall is a concrete slab with two prominent vertical cracks. The cracks are deep and run parallel to each other, extending from the base of the wall down into the slab.
<p>Photo 7</p> <p>View of the cracking up the driveway shows the root system has passed the edge of the building foundations and with time may cause structural damage to the building.</p>

In conclusion it is believed that the safest and cheapest option would be to remove the tree entirely, preventing future root growth and any further damage to the property.

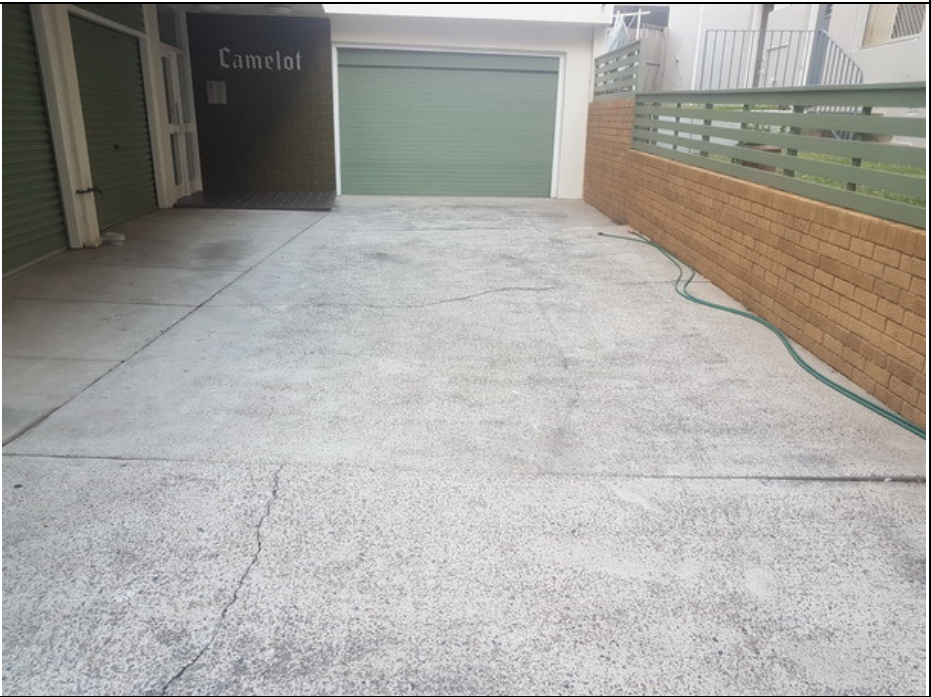
<p>Photo 8</p> <p>The driveway slab can be seen being lifted some 30m away from the tree on the street.</p>	 
<p>Photo 9</p> <p>The driveway and entry footpath can be seen being completely lifted off the ground from the front garden.</p>
