COUNCIL MEETING

CM/7.12/25.08 Charing Cross Streetscape Upgrade - Project Update

CM/7.14/25.08 Bronte Pool - Pump House Upgrade and Pump Replacement - Project Update

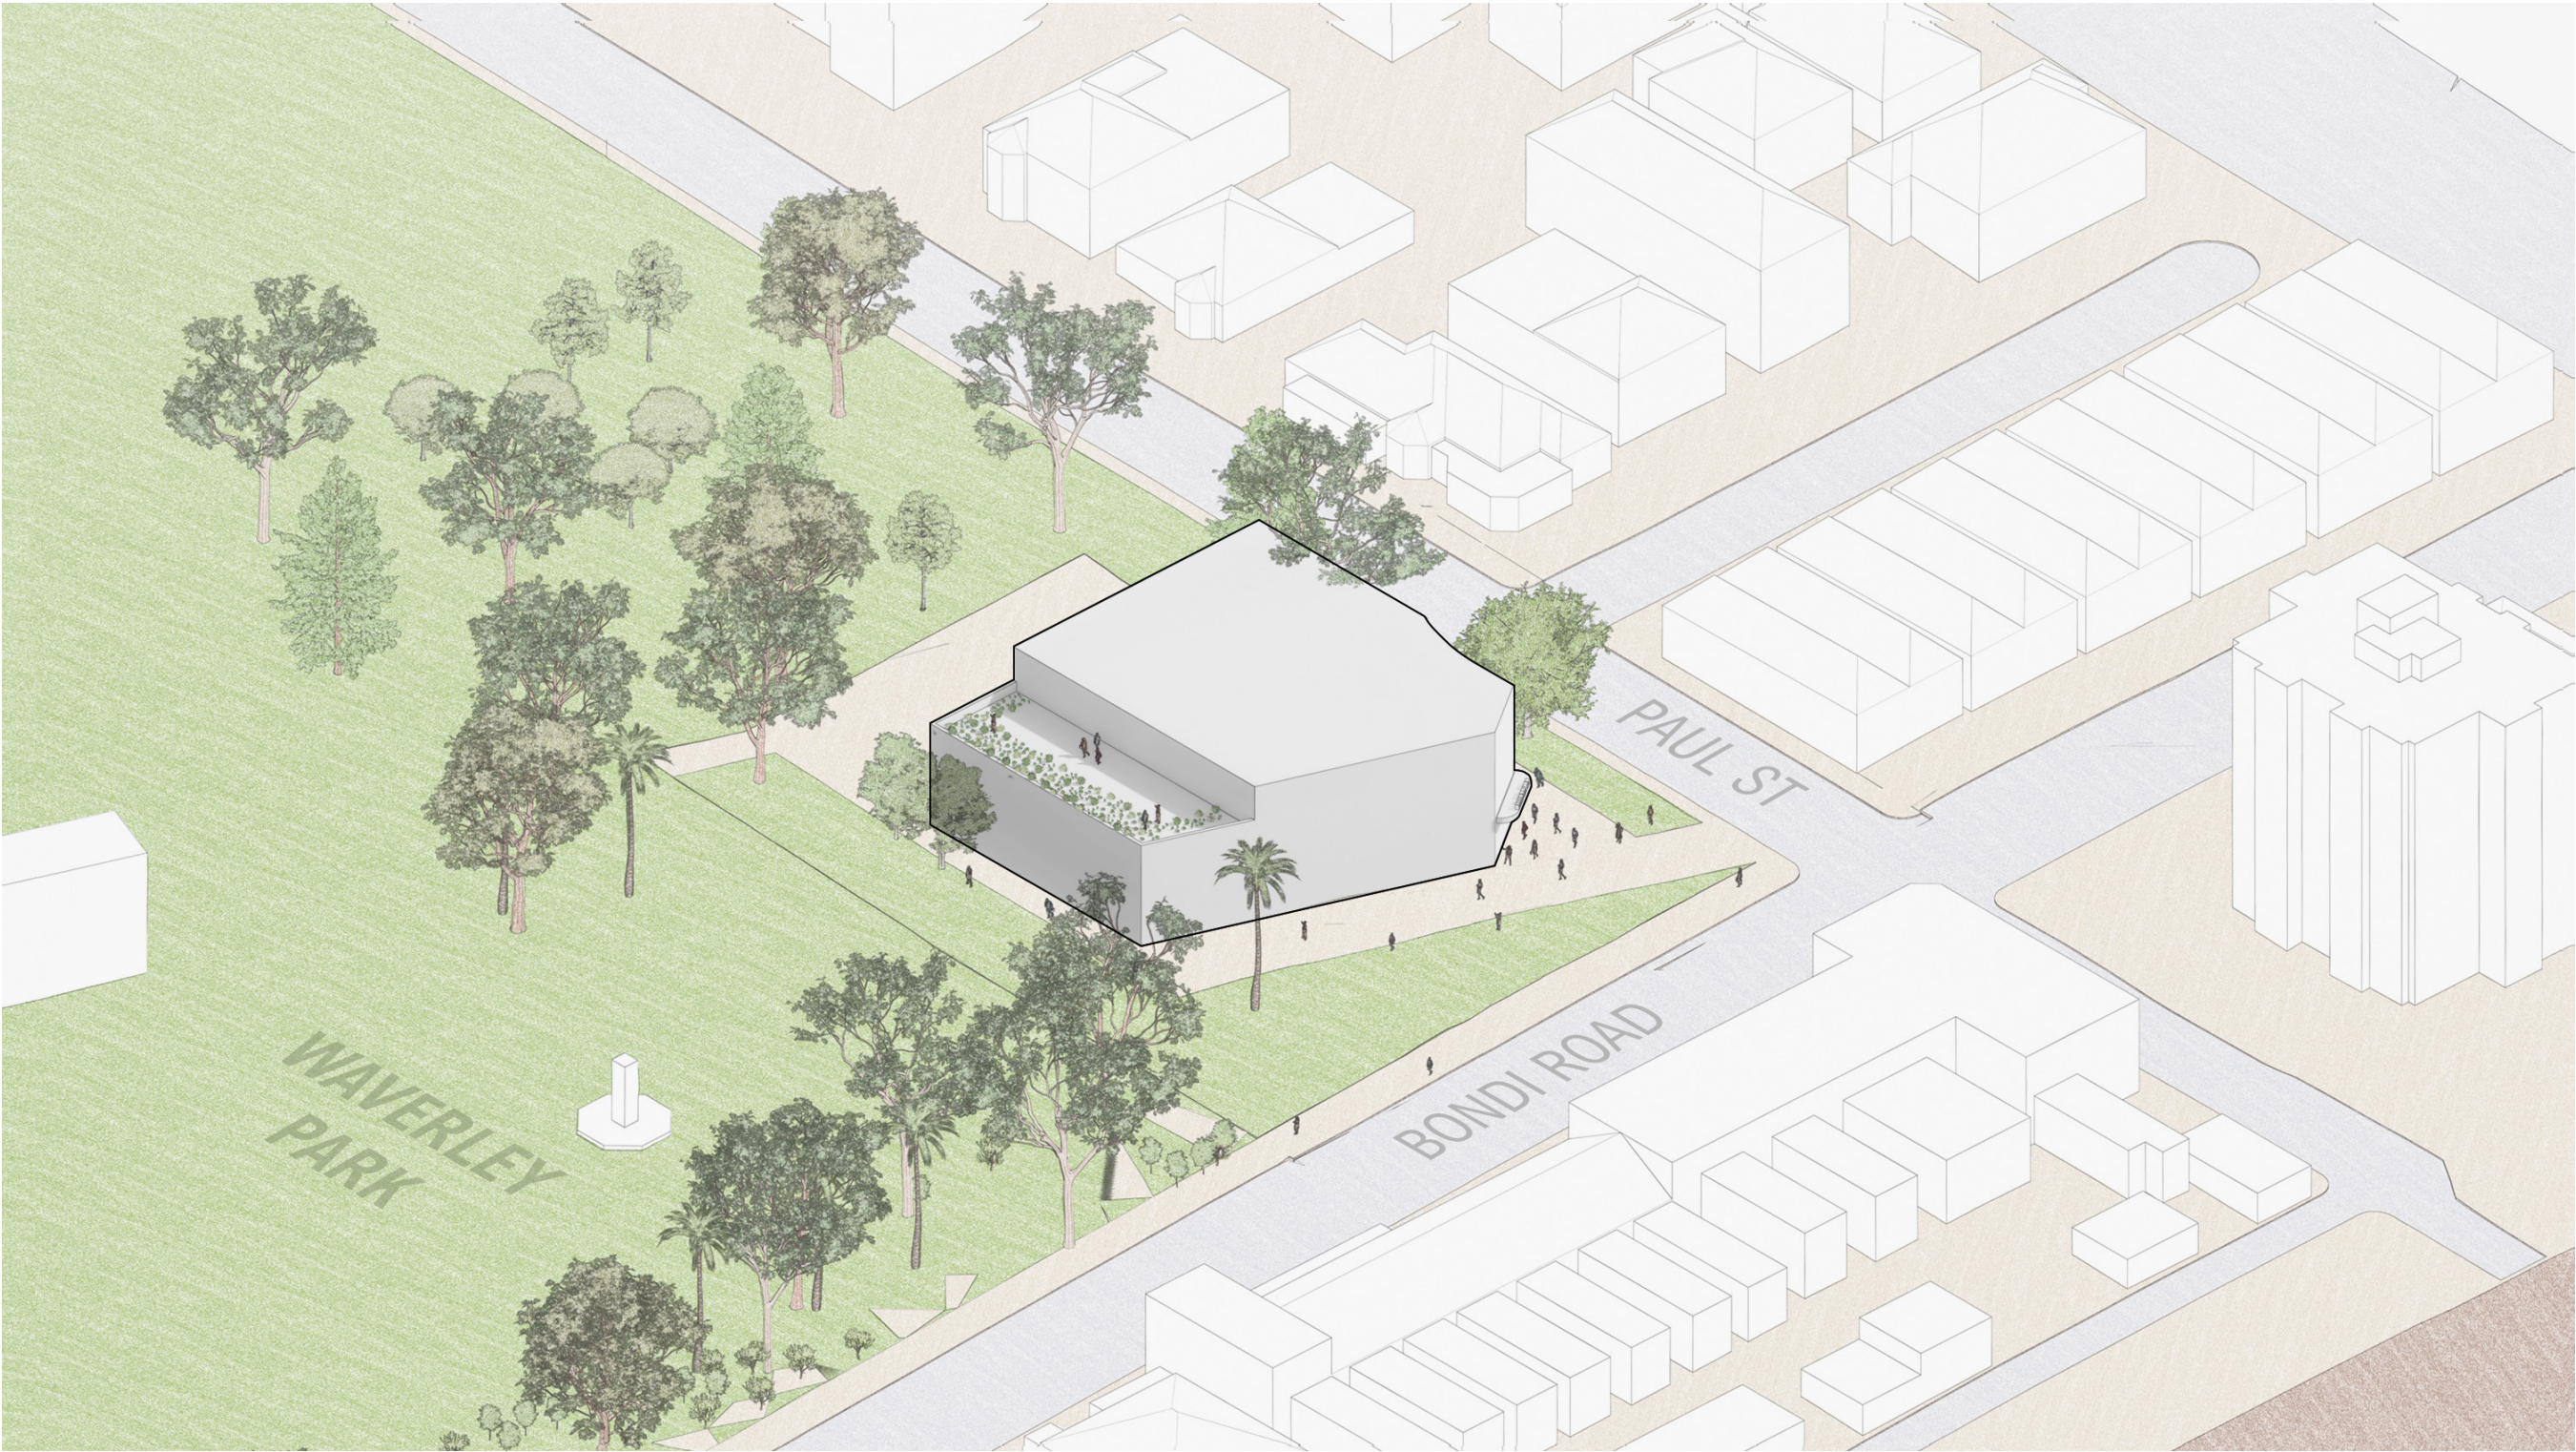
Option 3A - Isometric Concept Visualisation

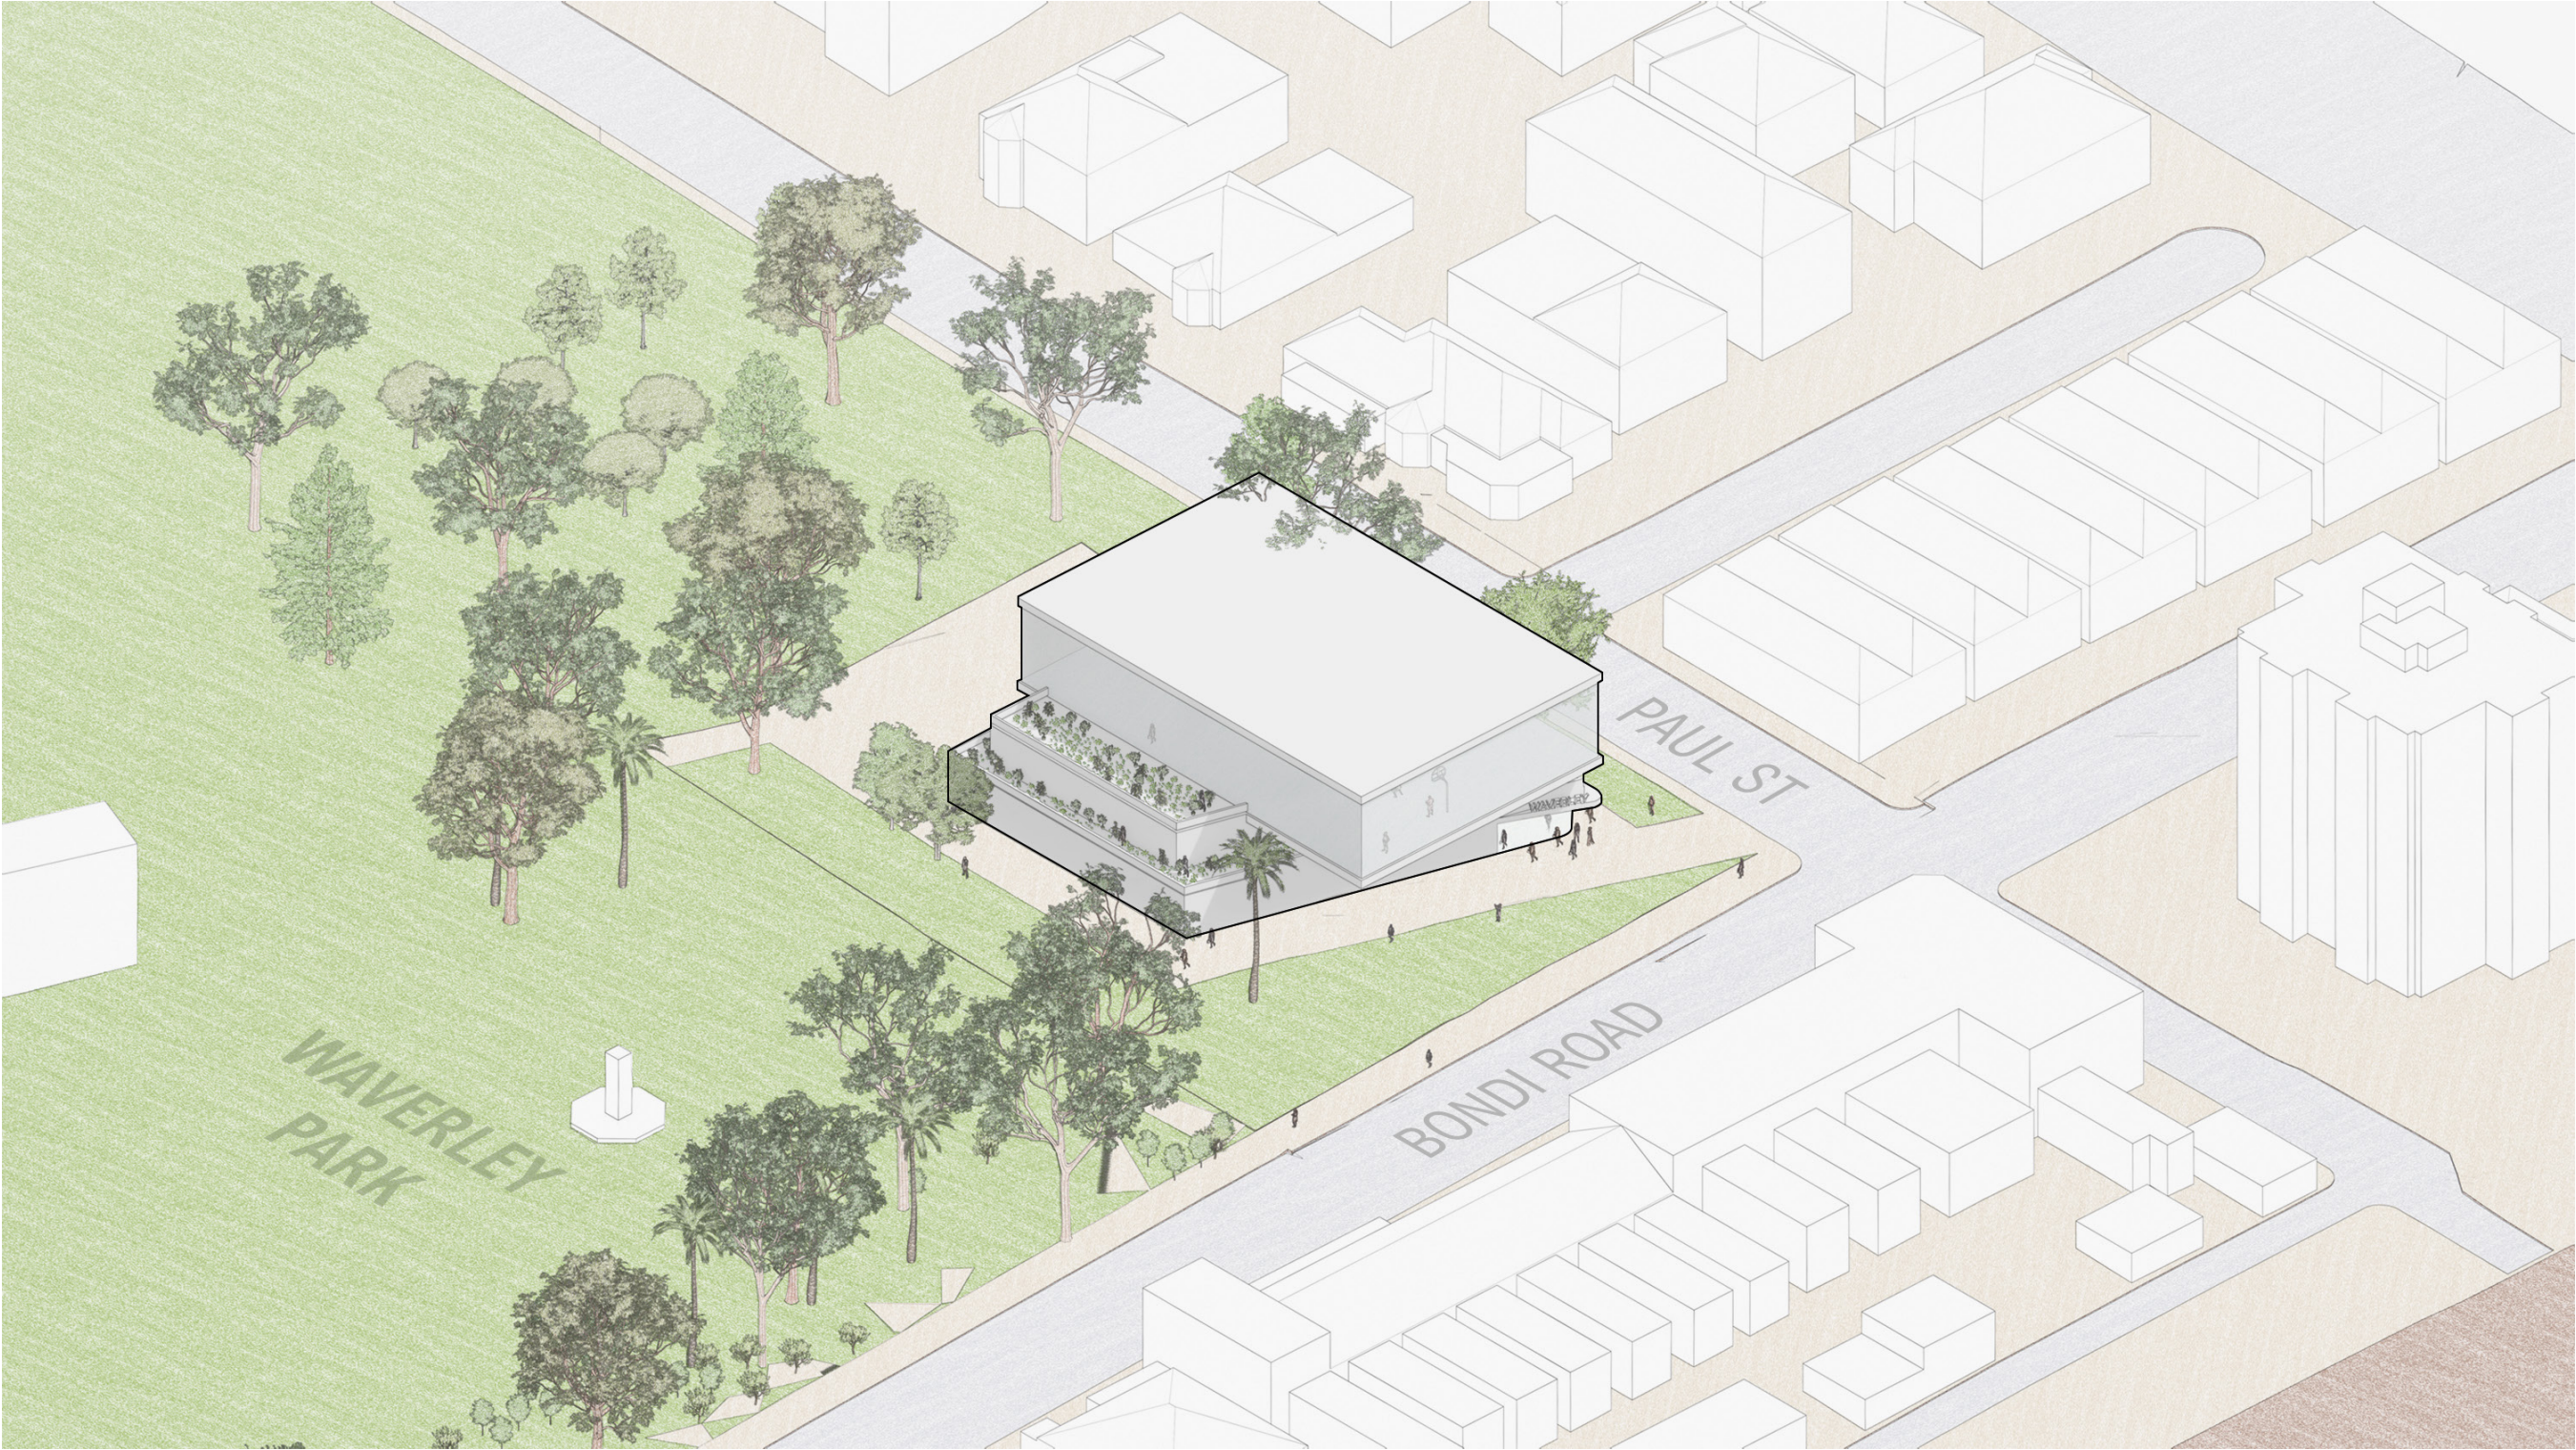
Option 3C - Isometric Concept Visualisation

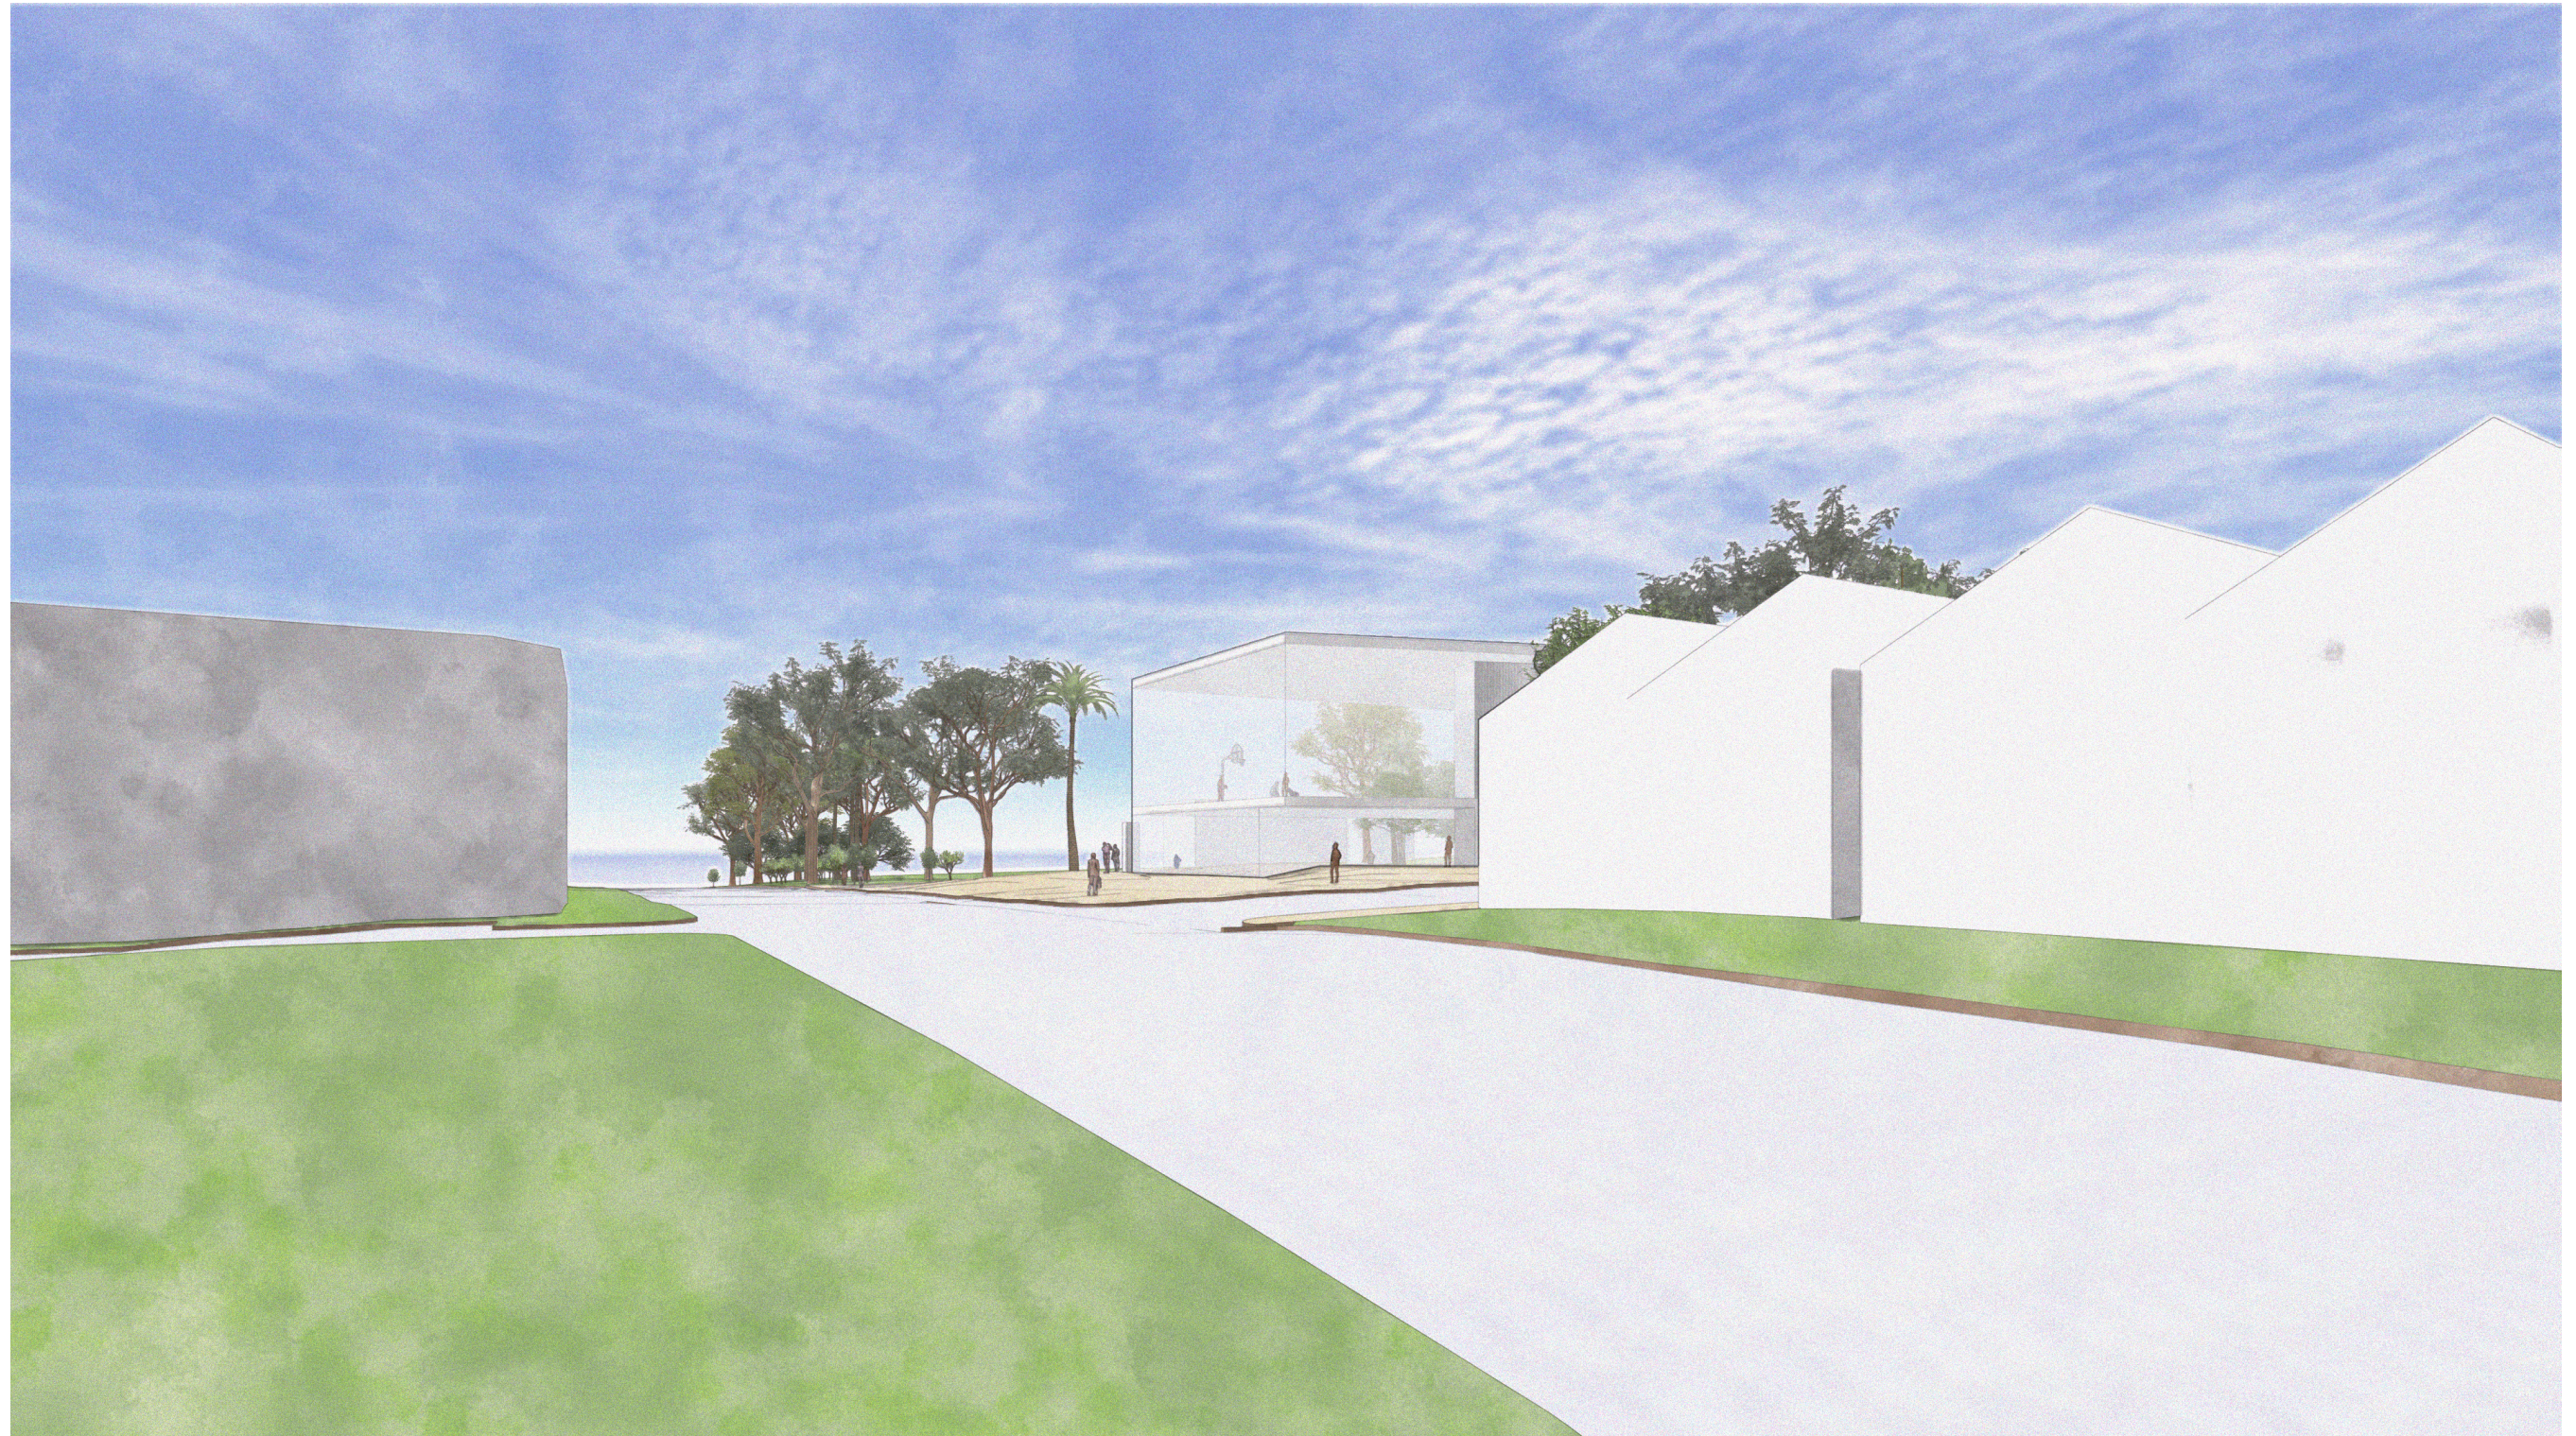
Option 1 - Concept Visualisation Bondi Road

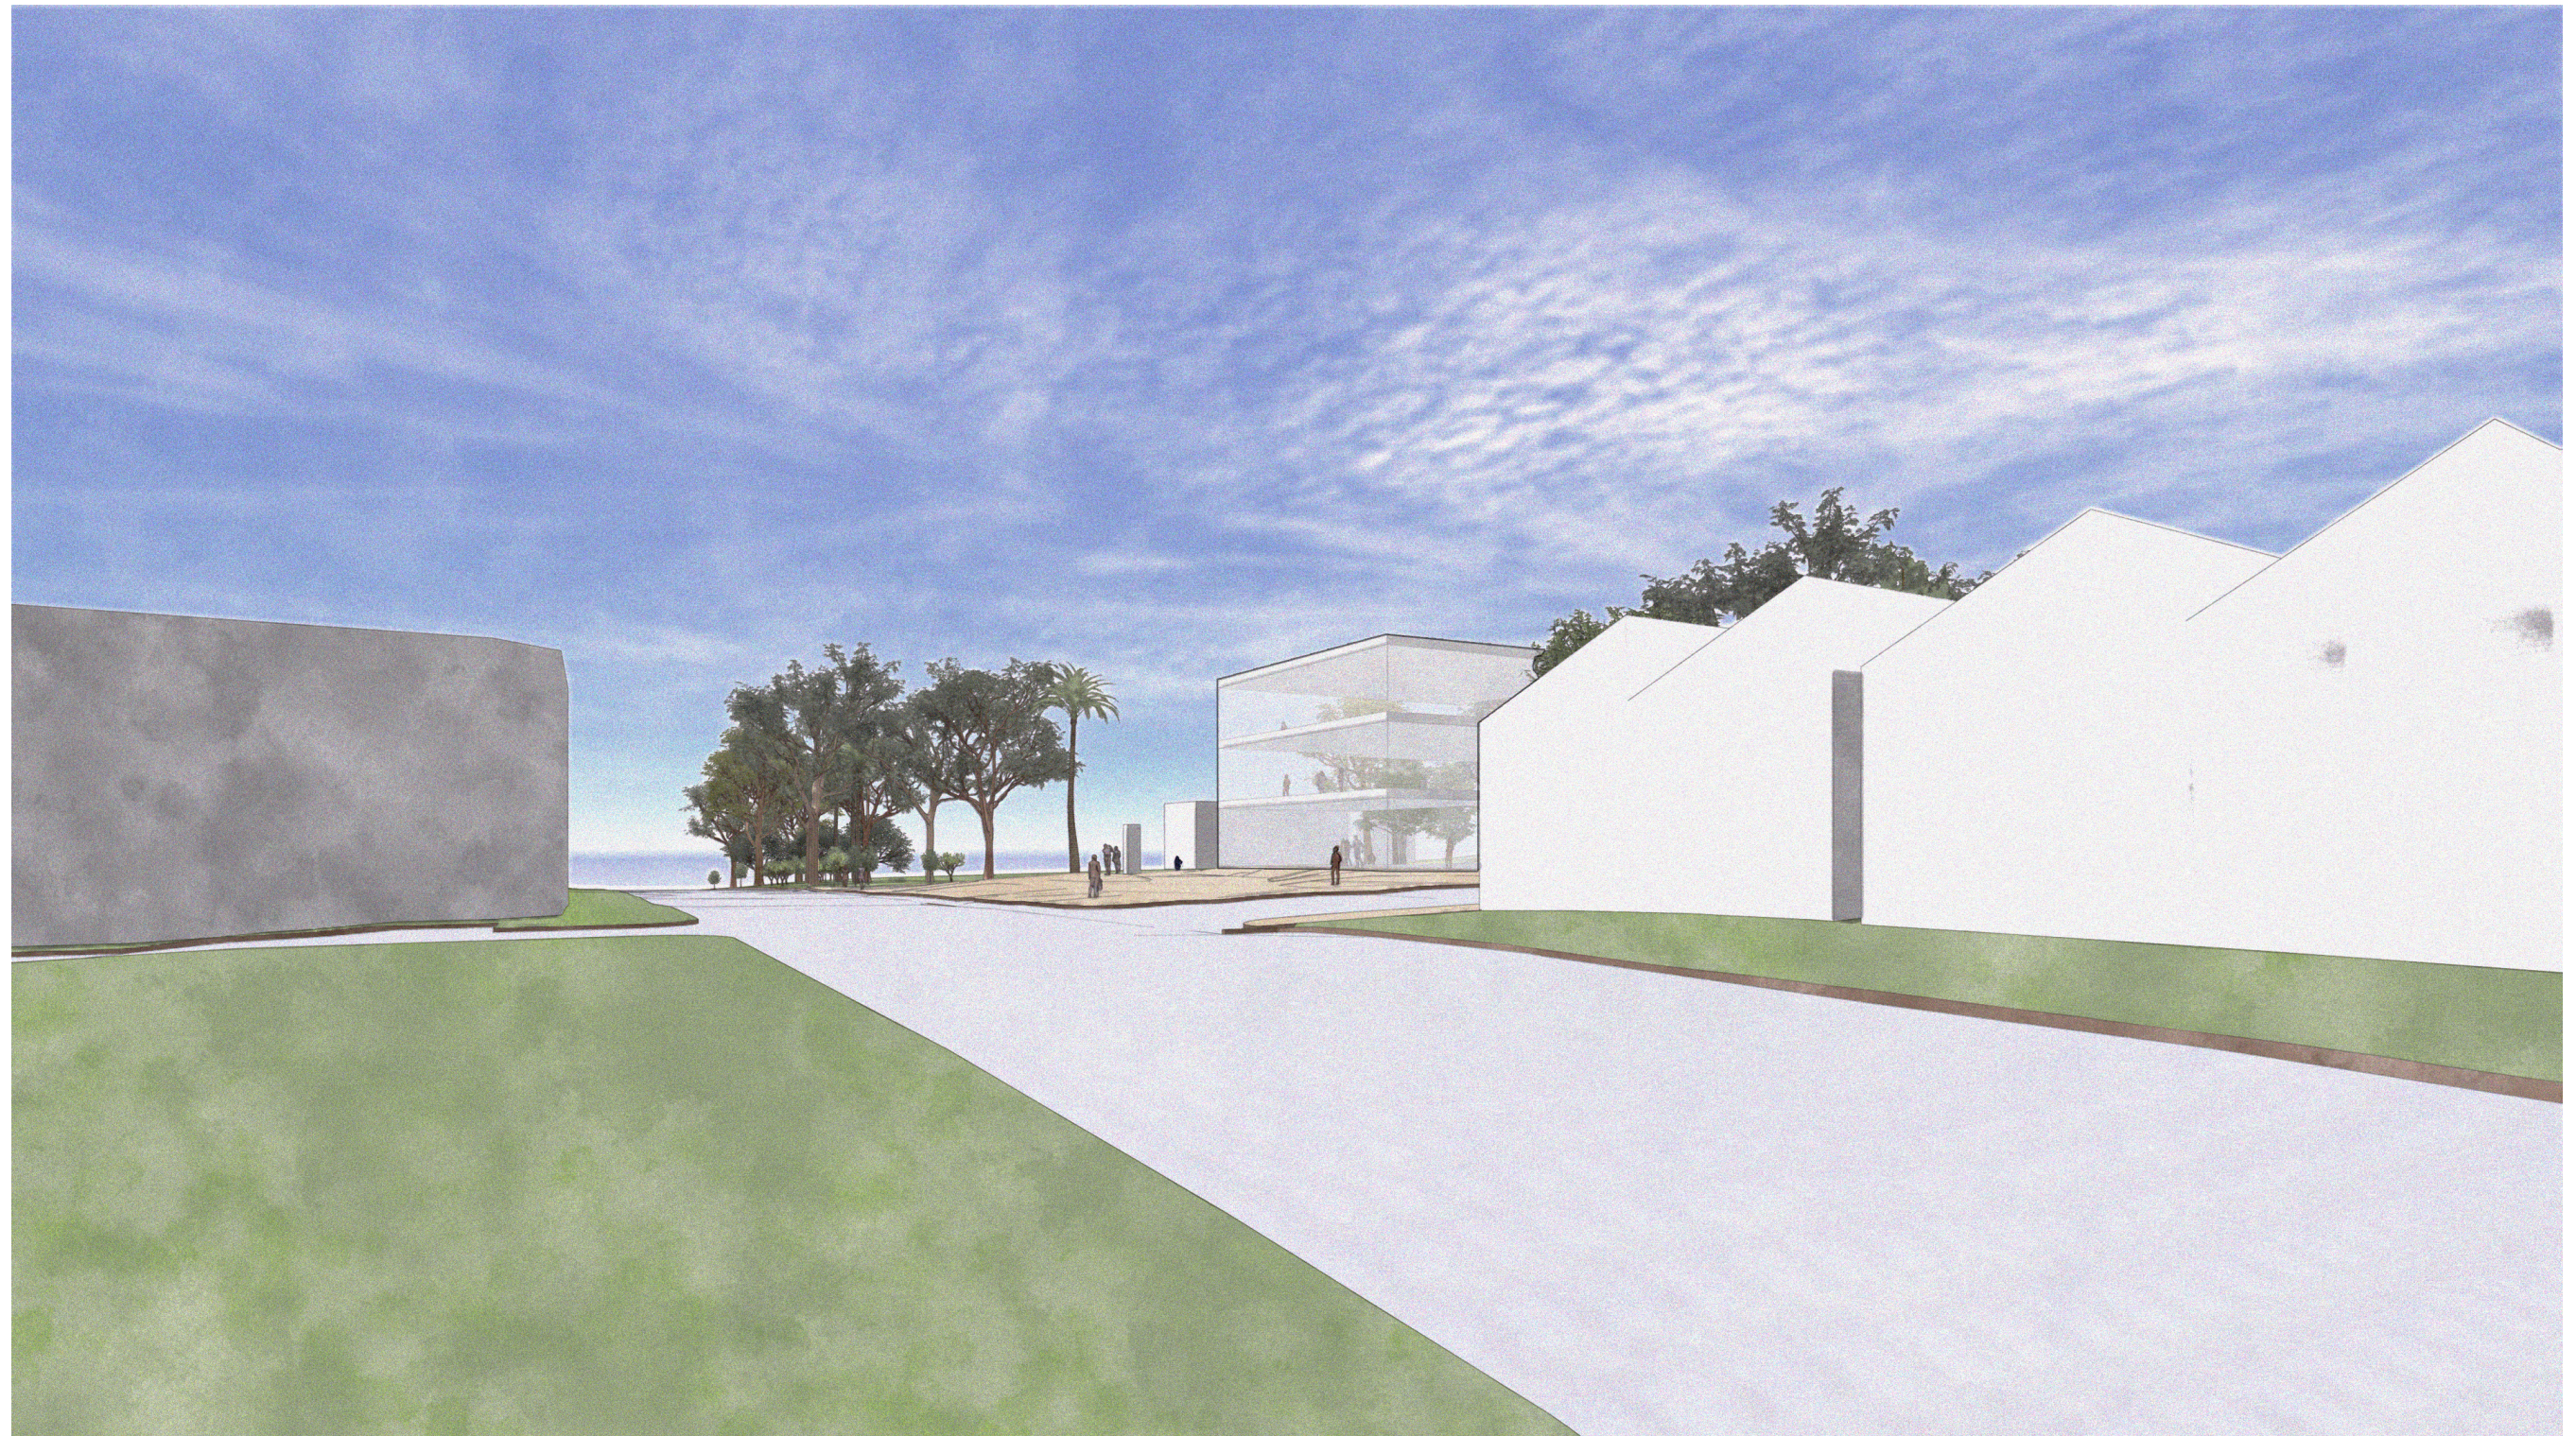
Option 2 - Concept Visualisation Bondi Road

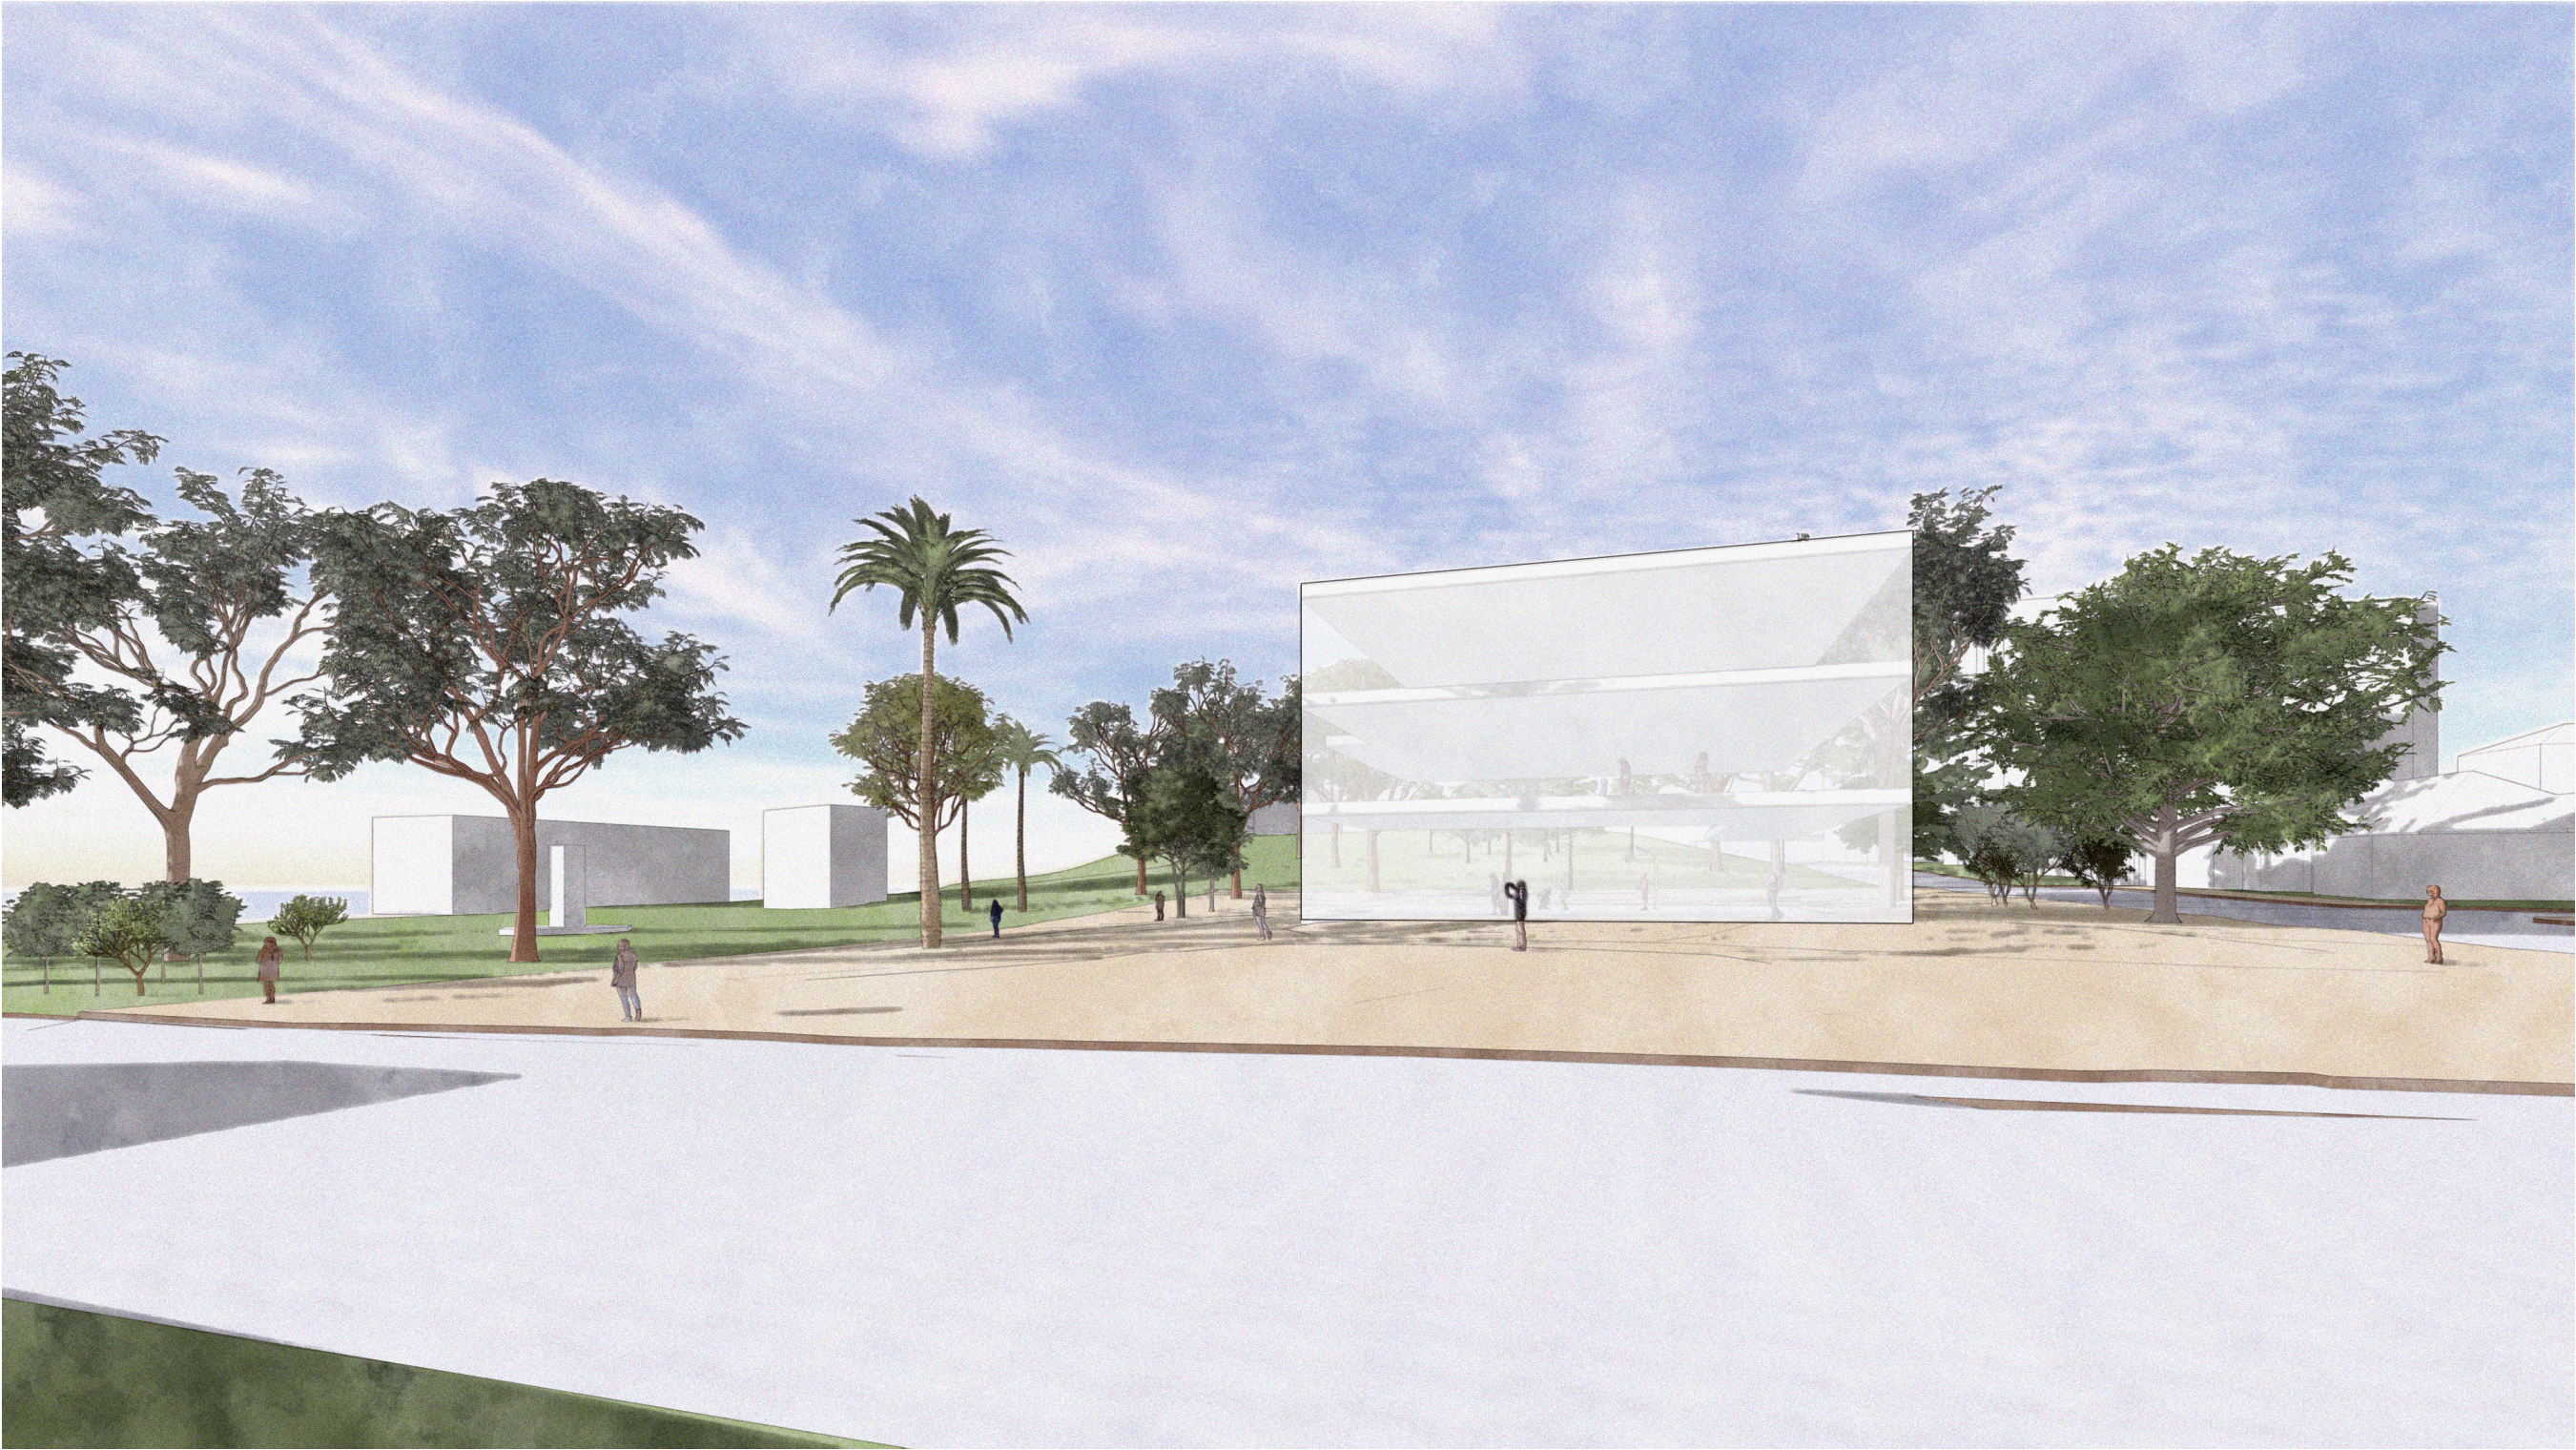
Option 2 - Concept Visualisation Bondi Road

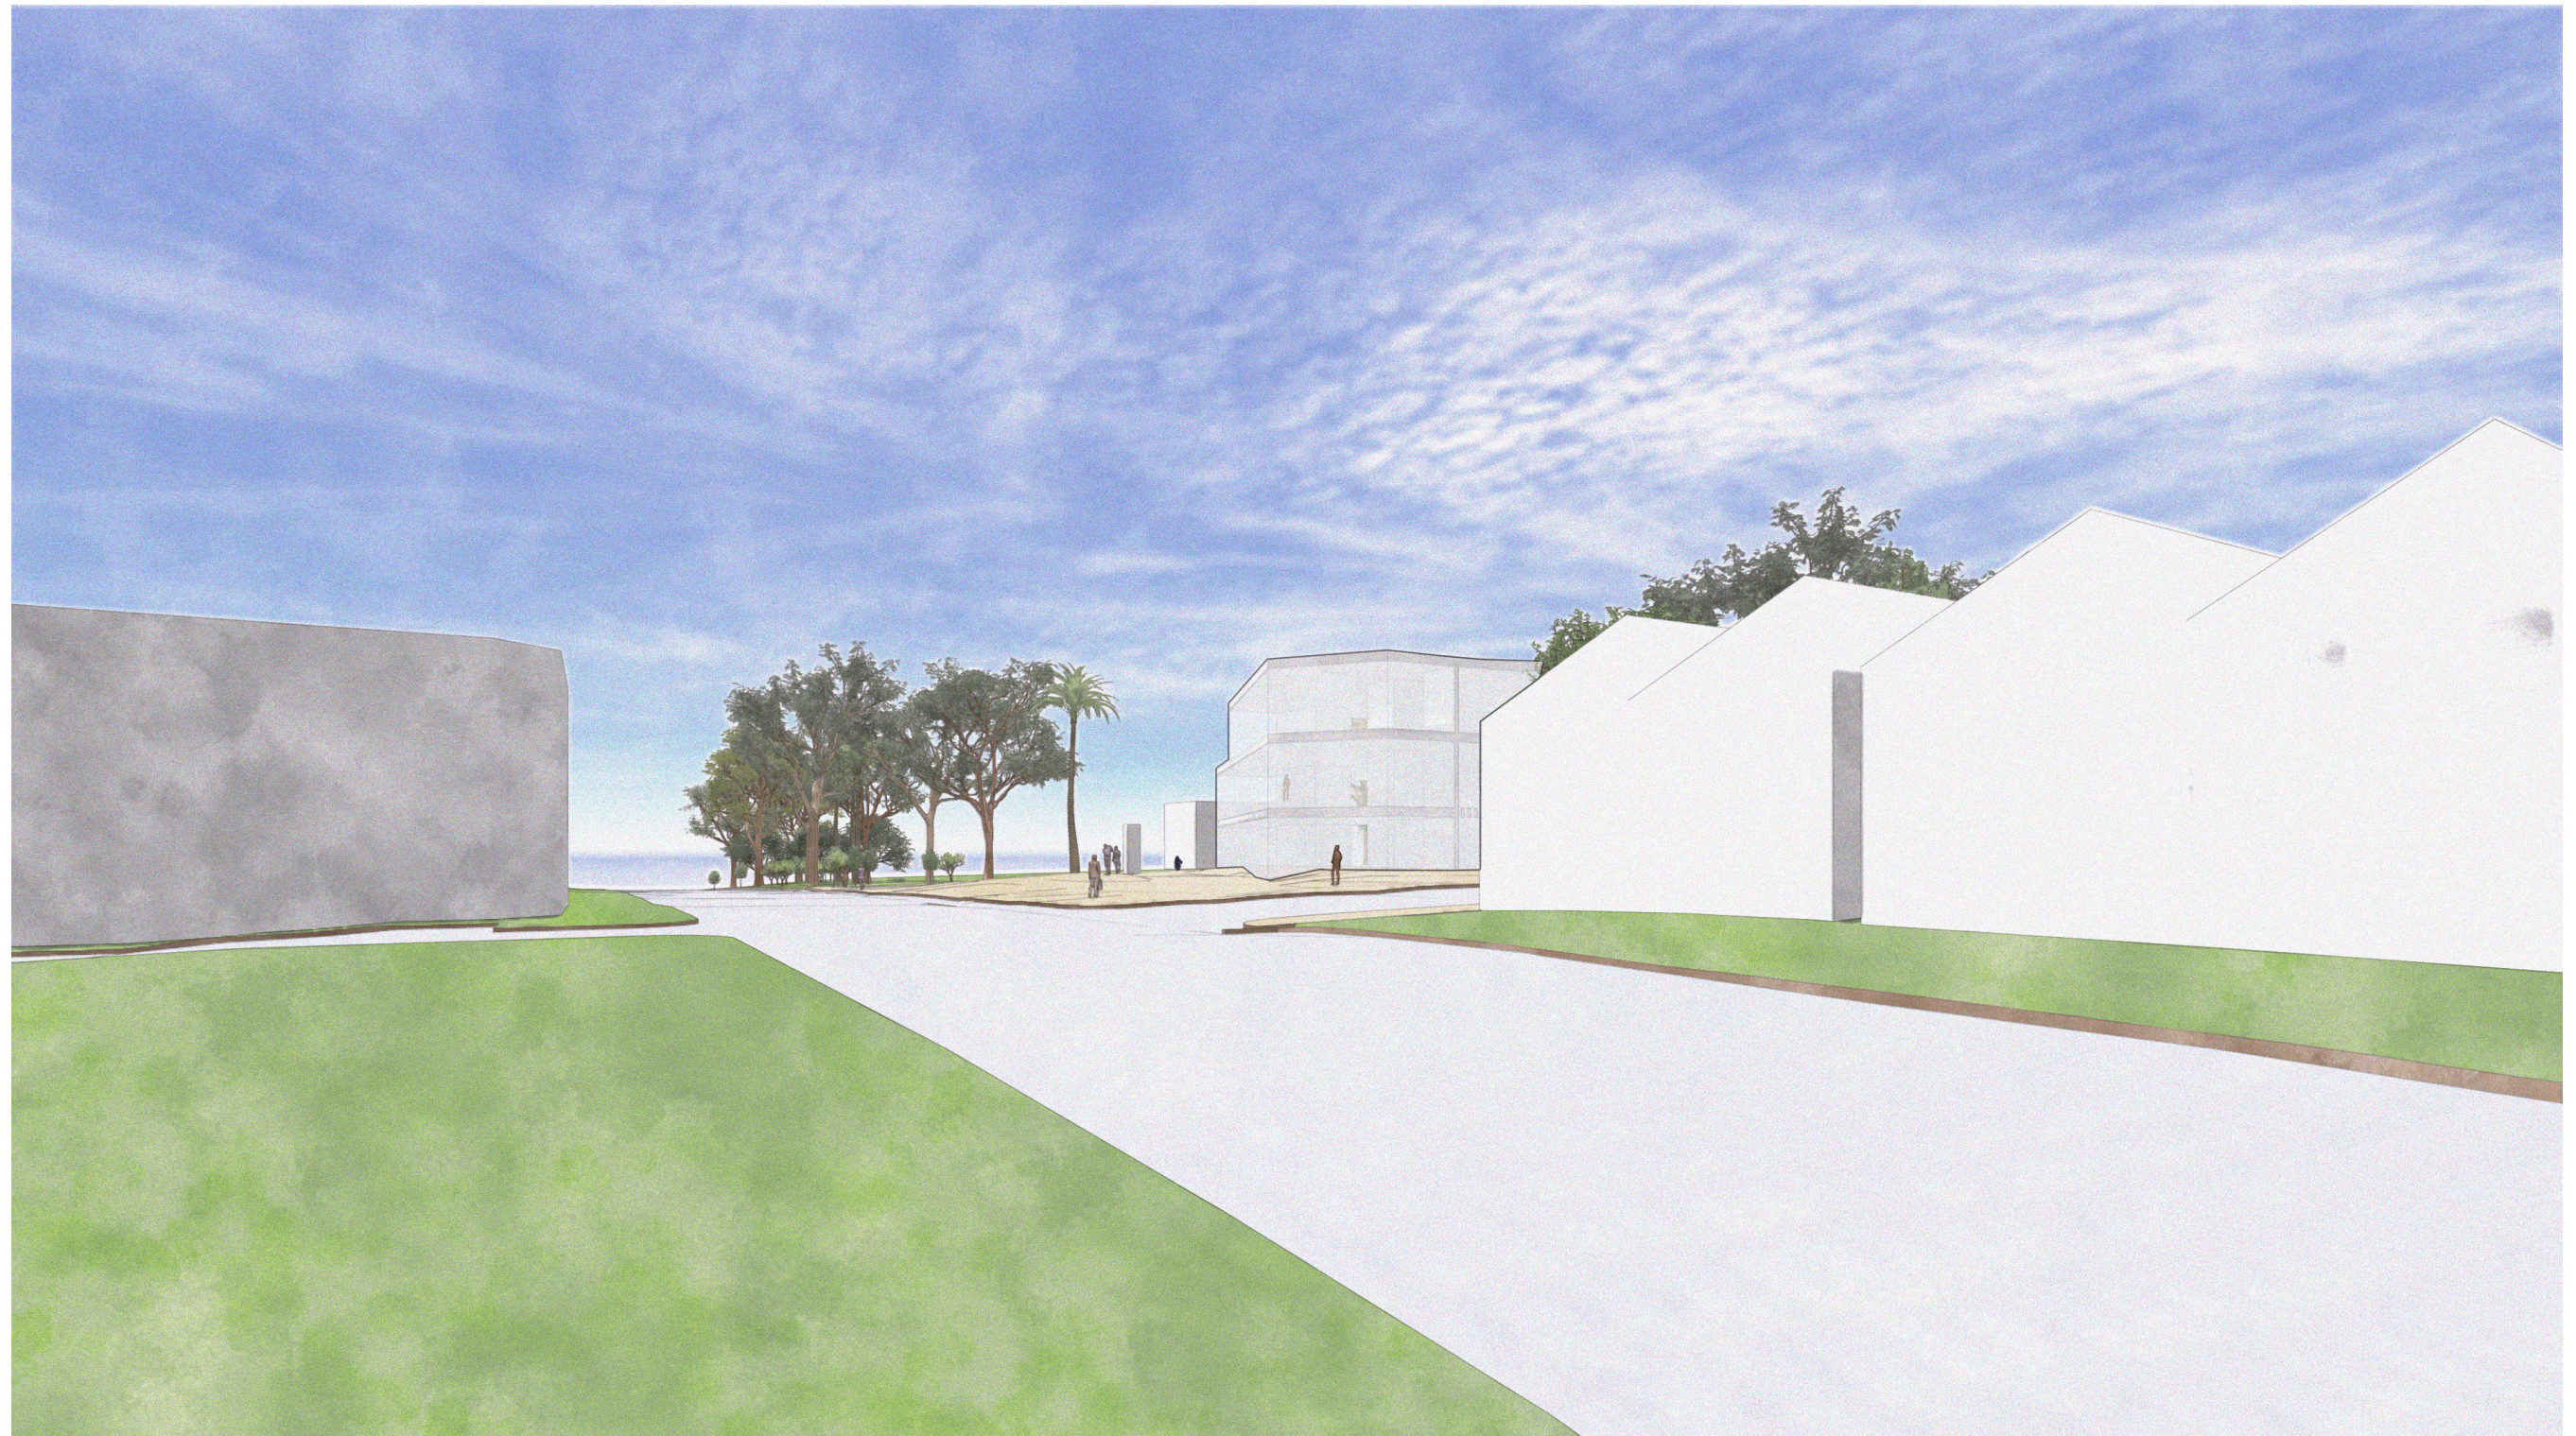
Option 3 - Concept Visualisation Bondi Road
