COUNCIL MEETING

CM/7.12/25.08 Charing Cross Streetscape Upgrade - Project Update

CM/7.14/25.08 Bronte Pool - Pump House Upgrade and Pump Replacement - Project Update

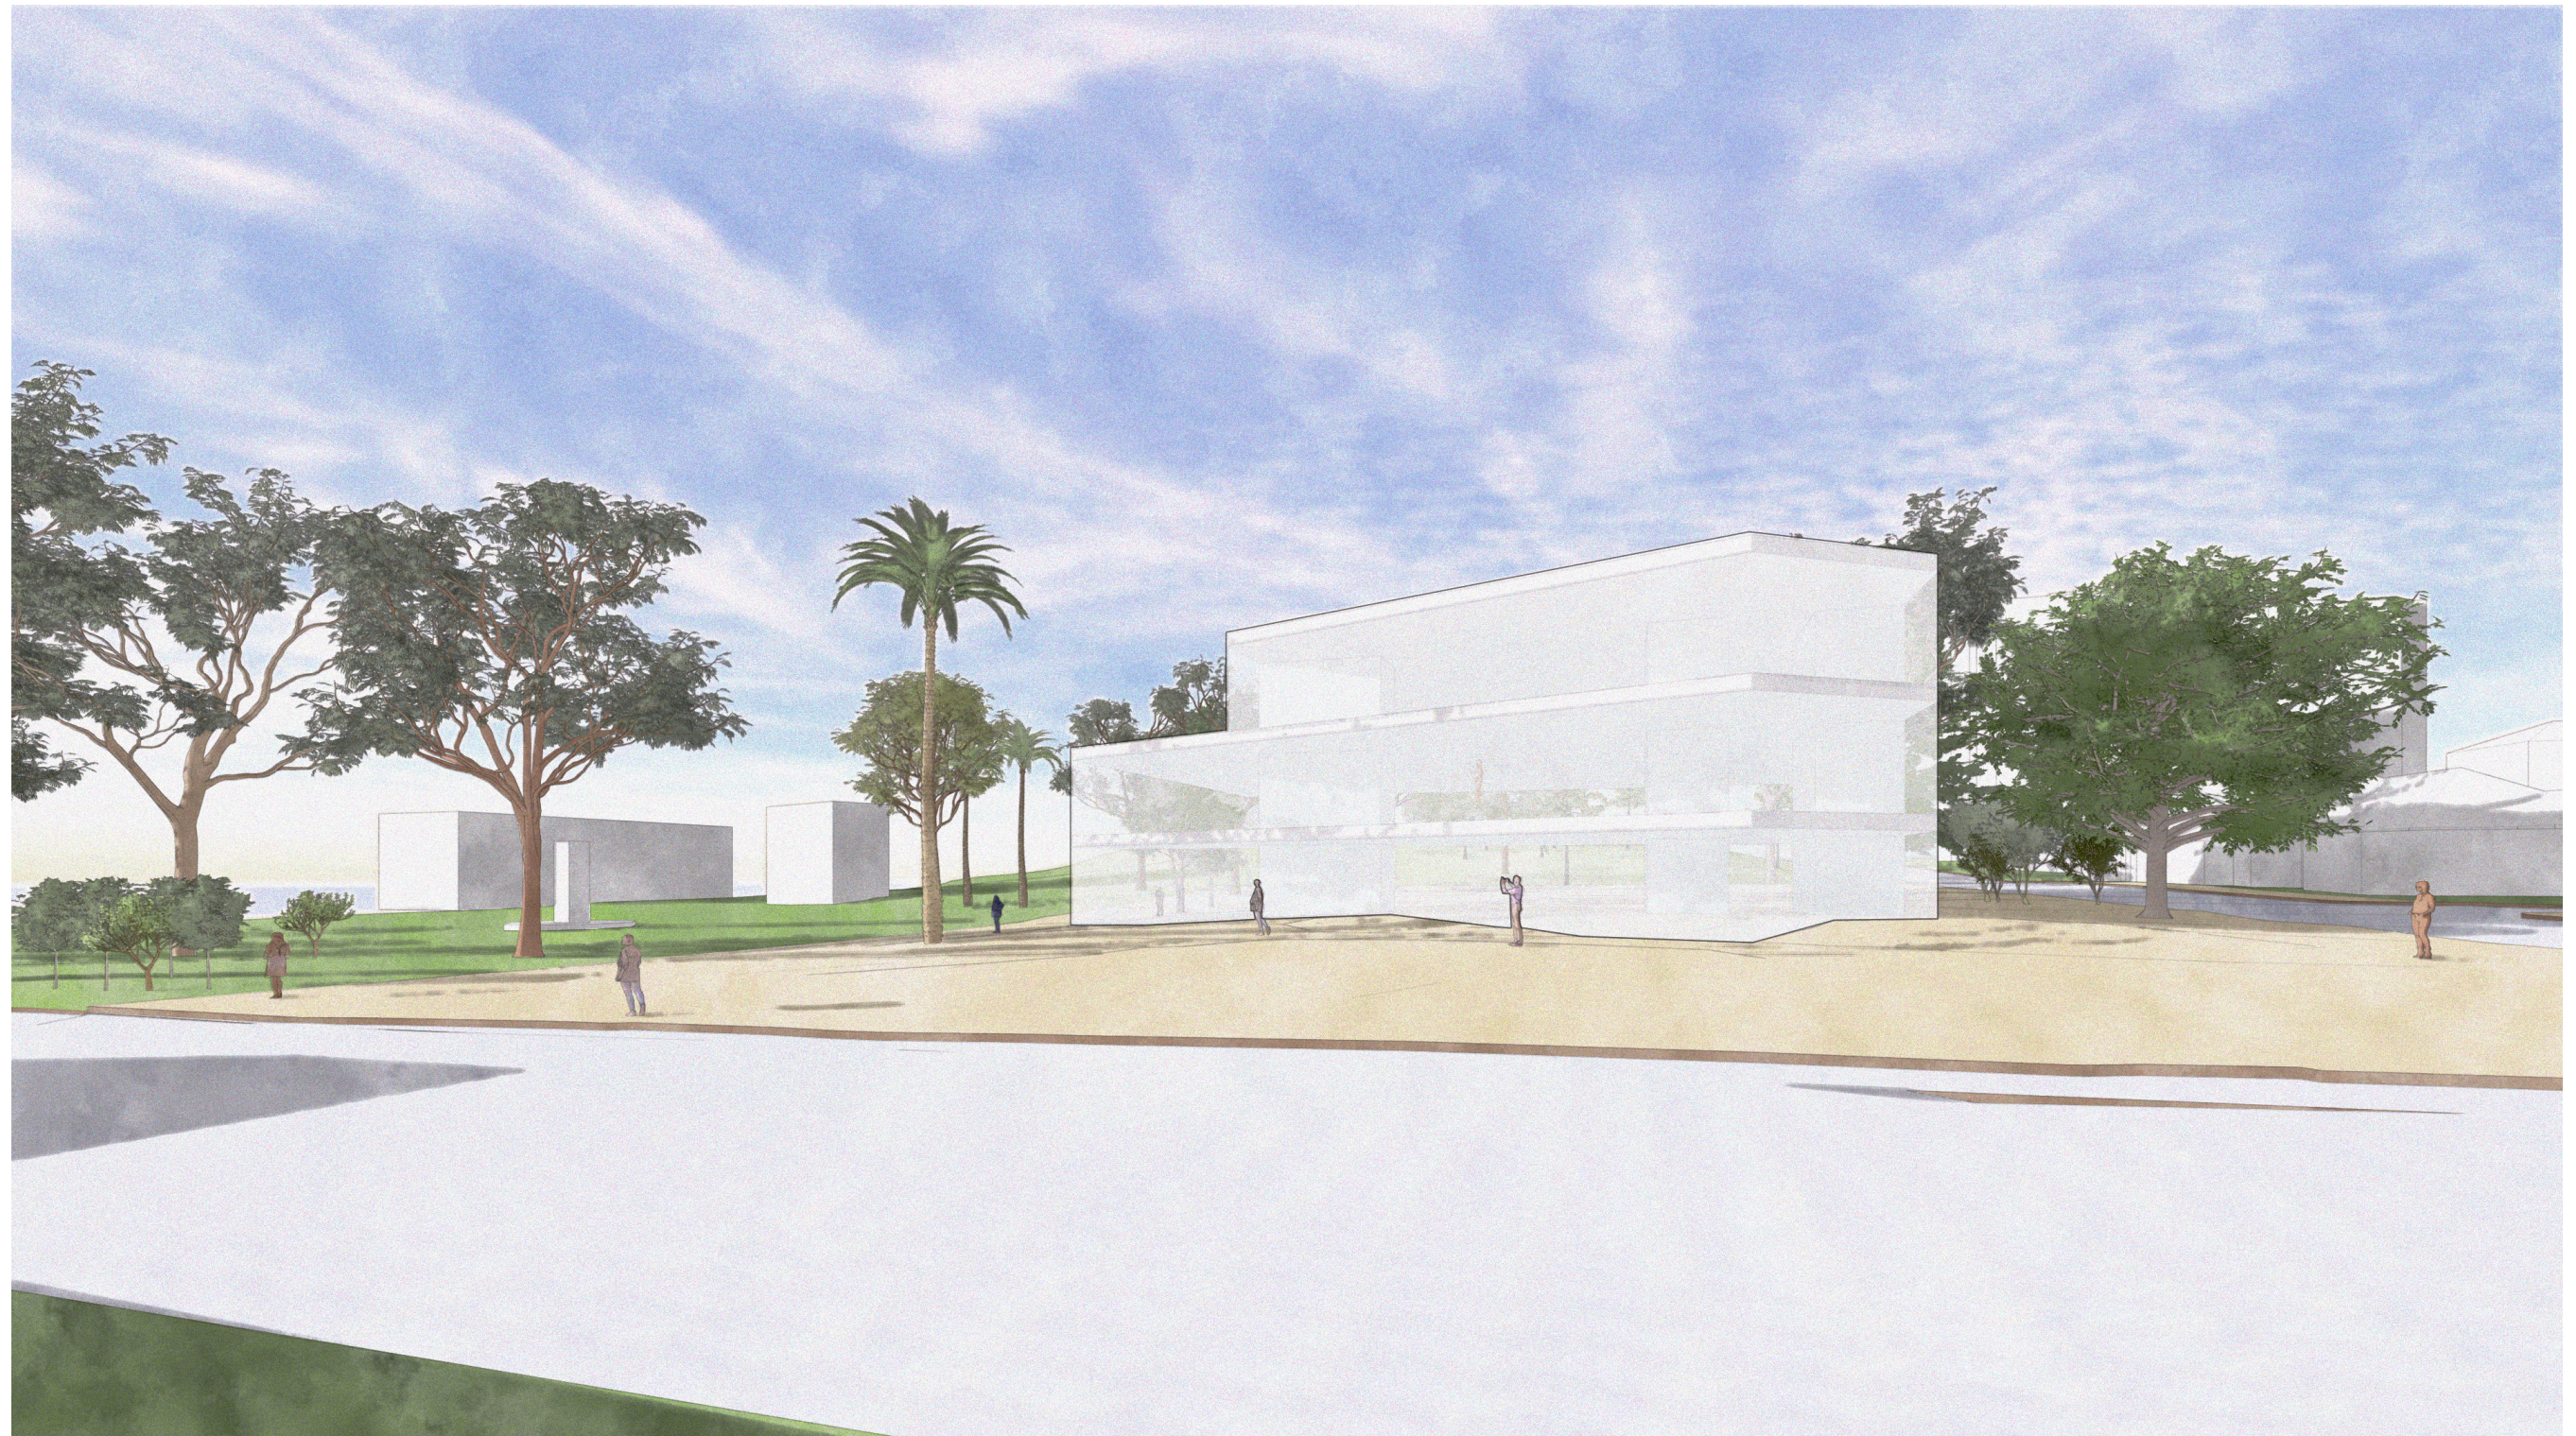
Option 3 - Concept Visualisation Bondi Road

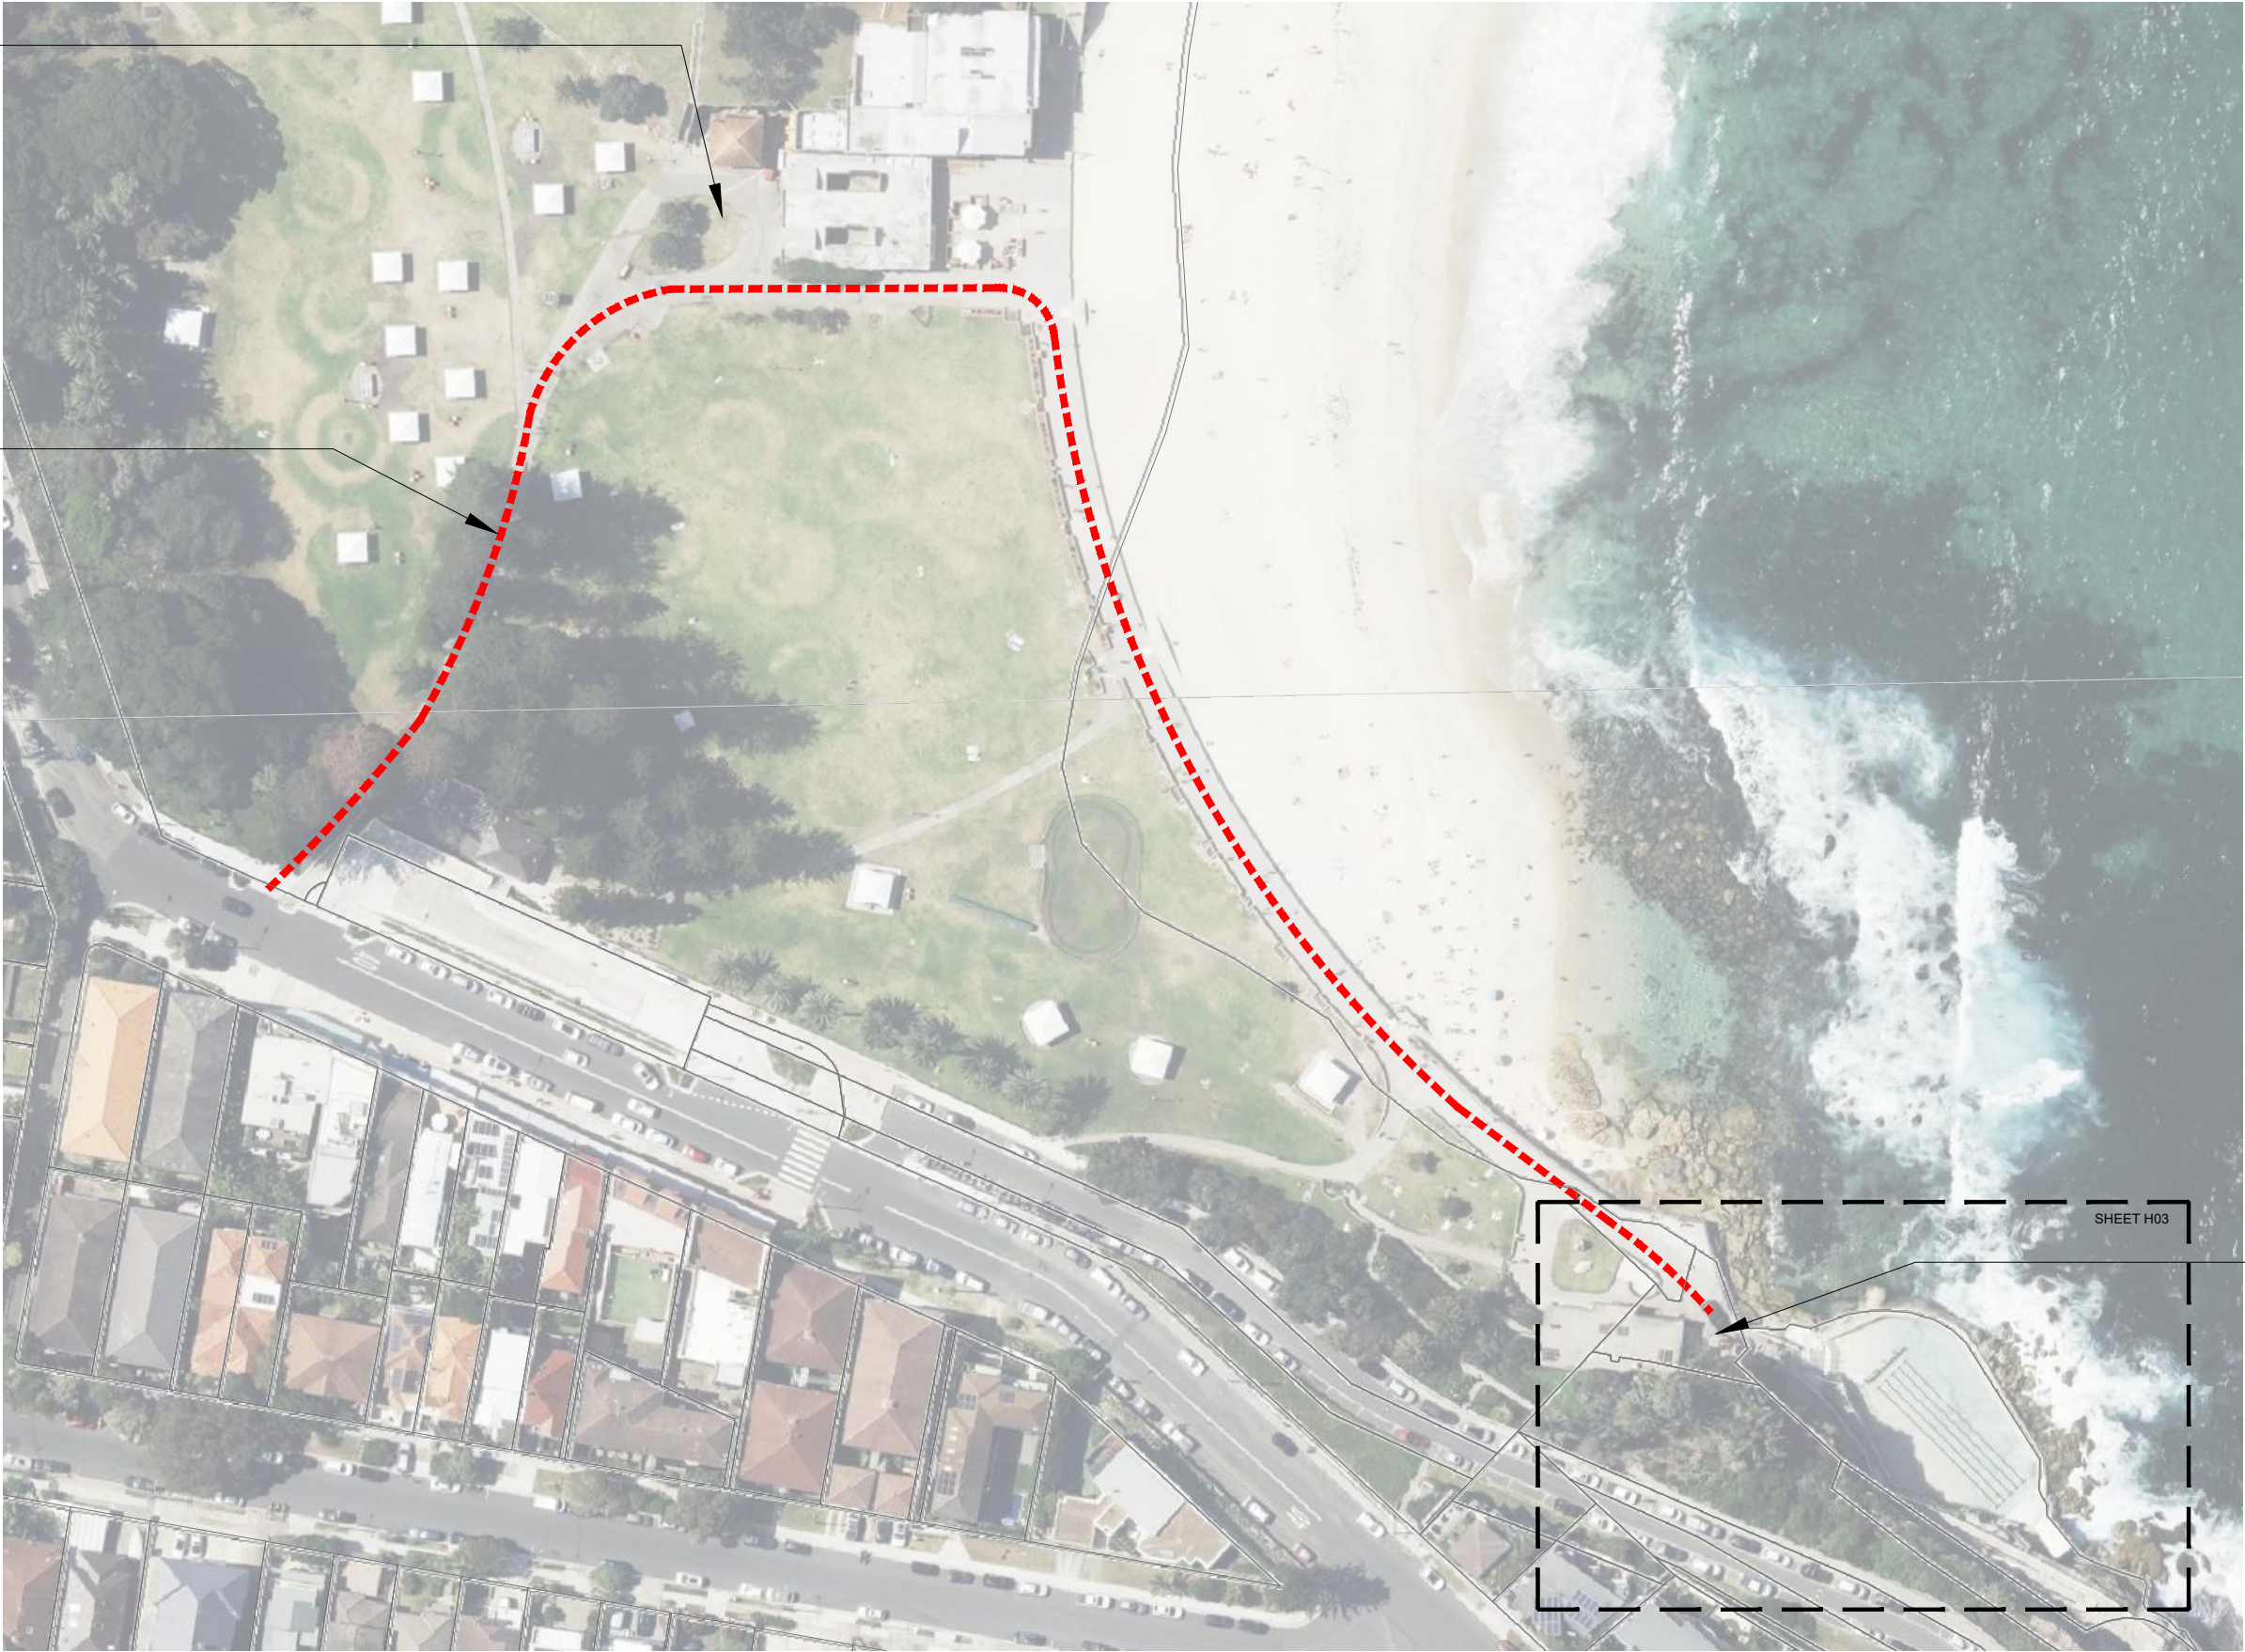
Phase
Design Development
Sheet Title
Site vehicle access plan
Sheet No.
H02

ROUTE FOR ALL
VEHICLES. SAFETY
PROTOCOLS (E.G.
SPOTTER) MUST BE
FOLLOWED

SITE COMPOUND.
REFER TO SHEET H03

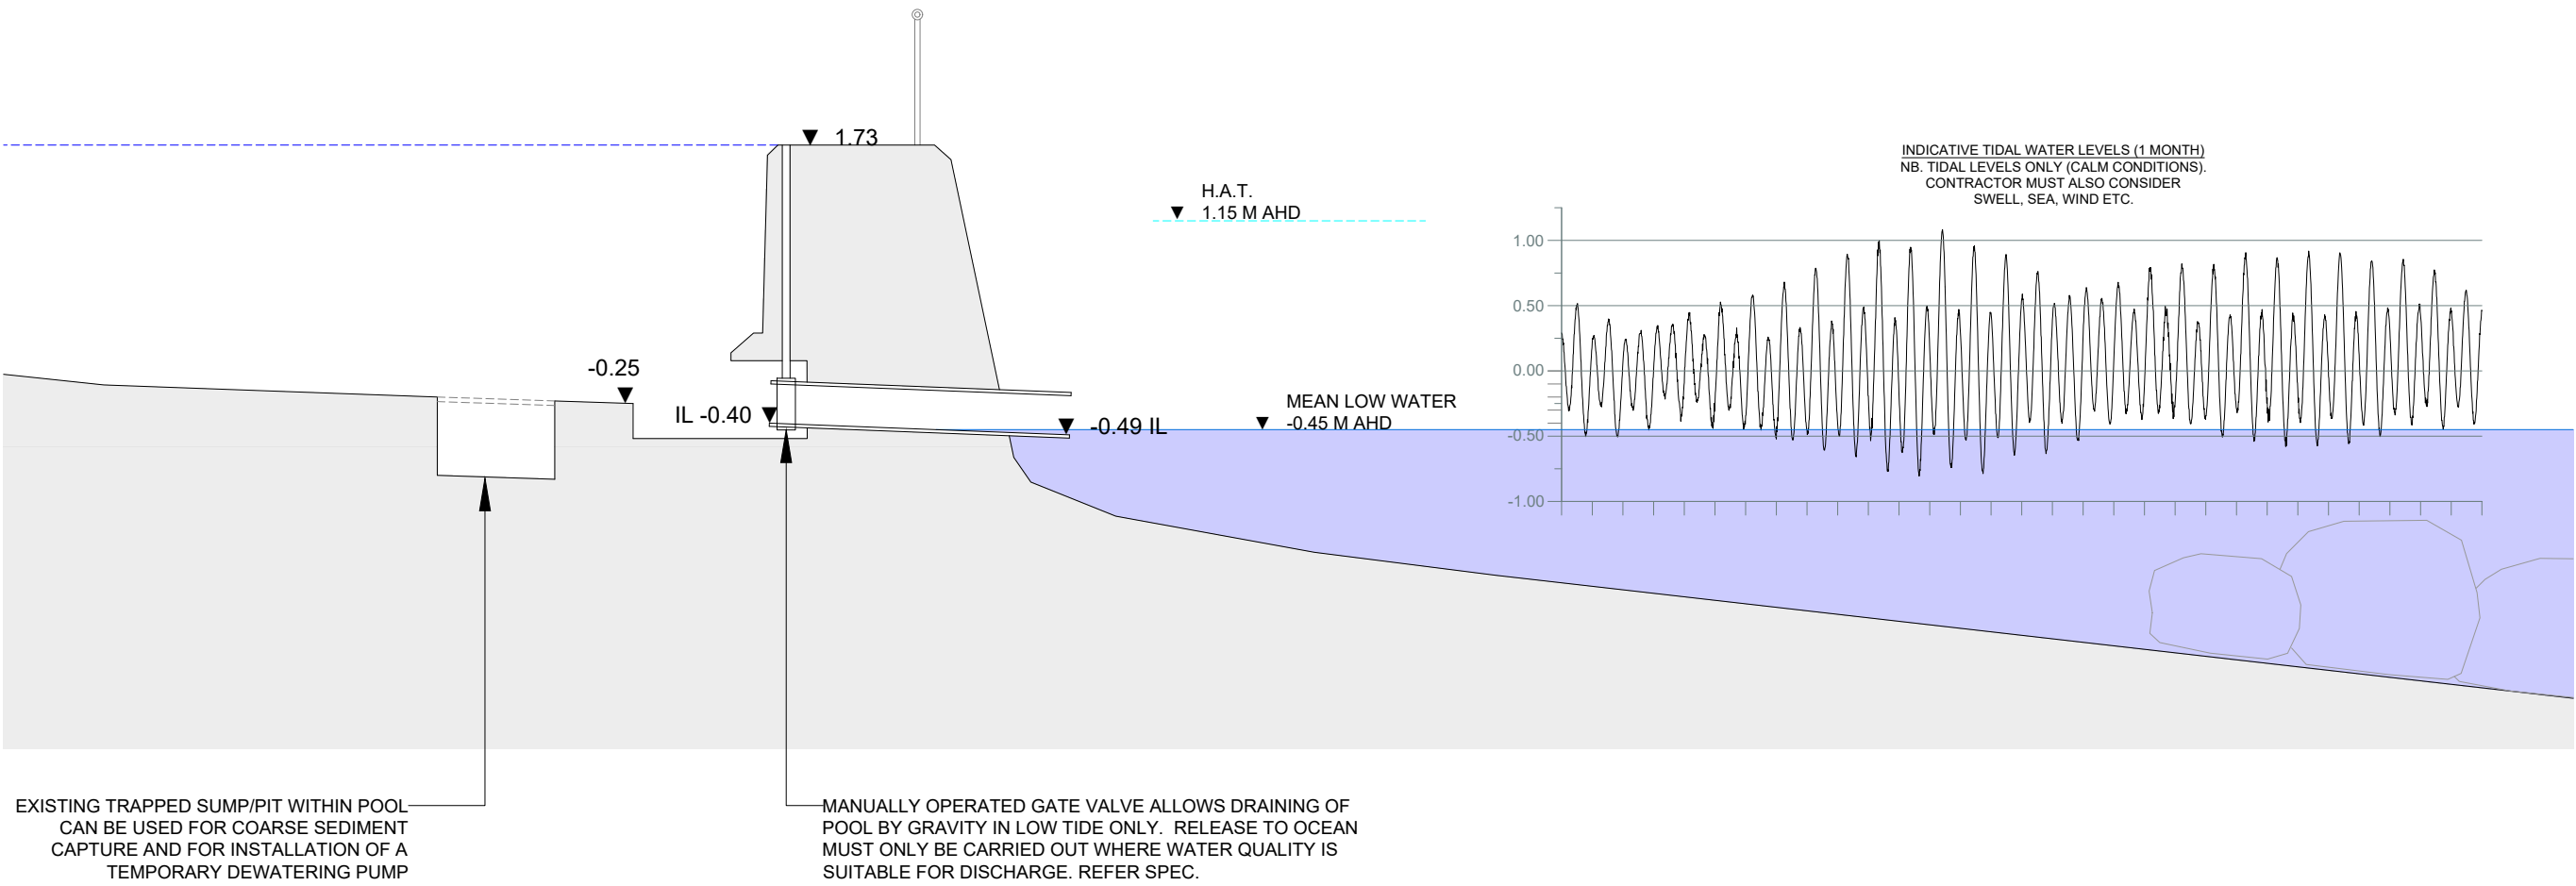
SECTION H04-1
EXISTING POOL OUTLET - INDICATIVE
1:25 @ A1

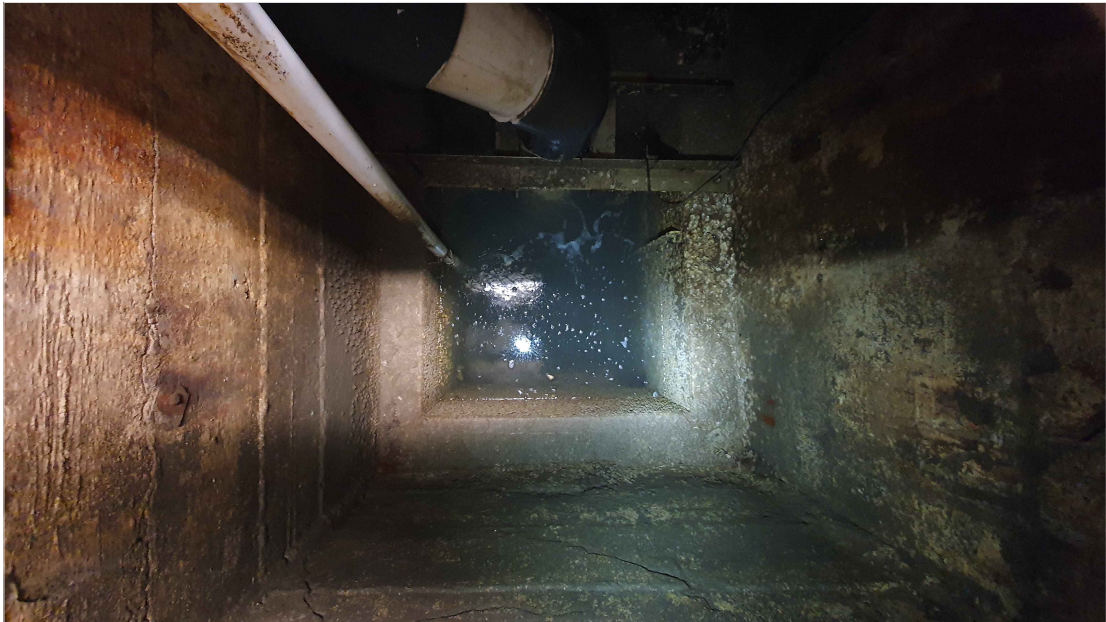
IMAGE 1 - LOOKING DOWN INTO PUMP SUMP

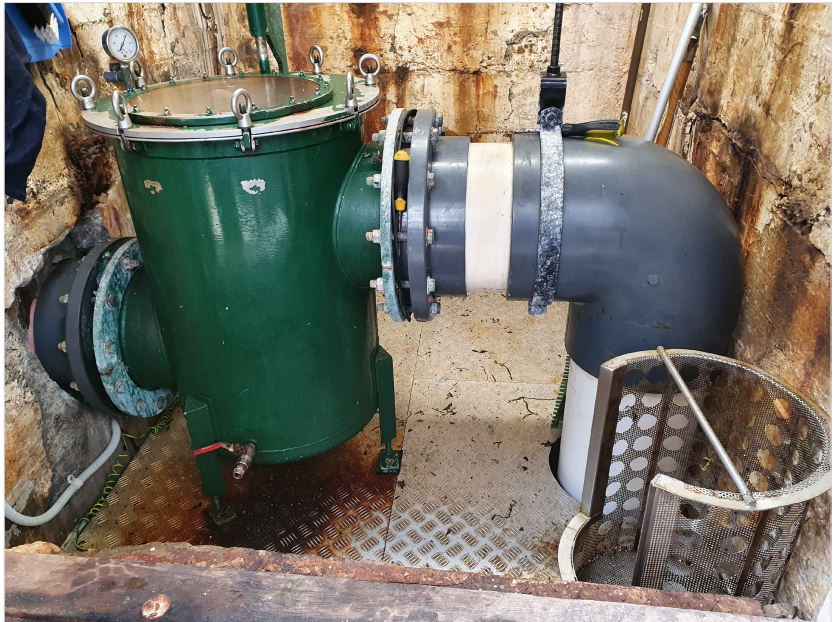
IMAGE 2 - PLATFORM AND BASKET STRAINER ABOVE PUMP SUMP

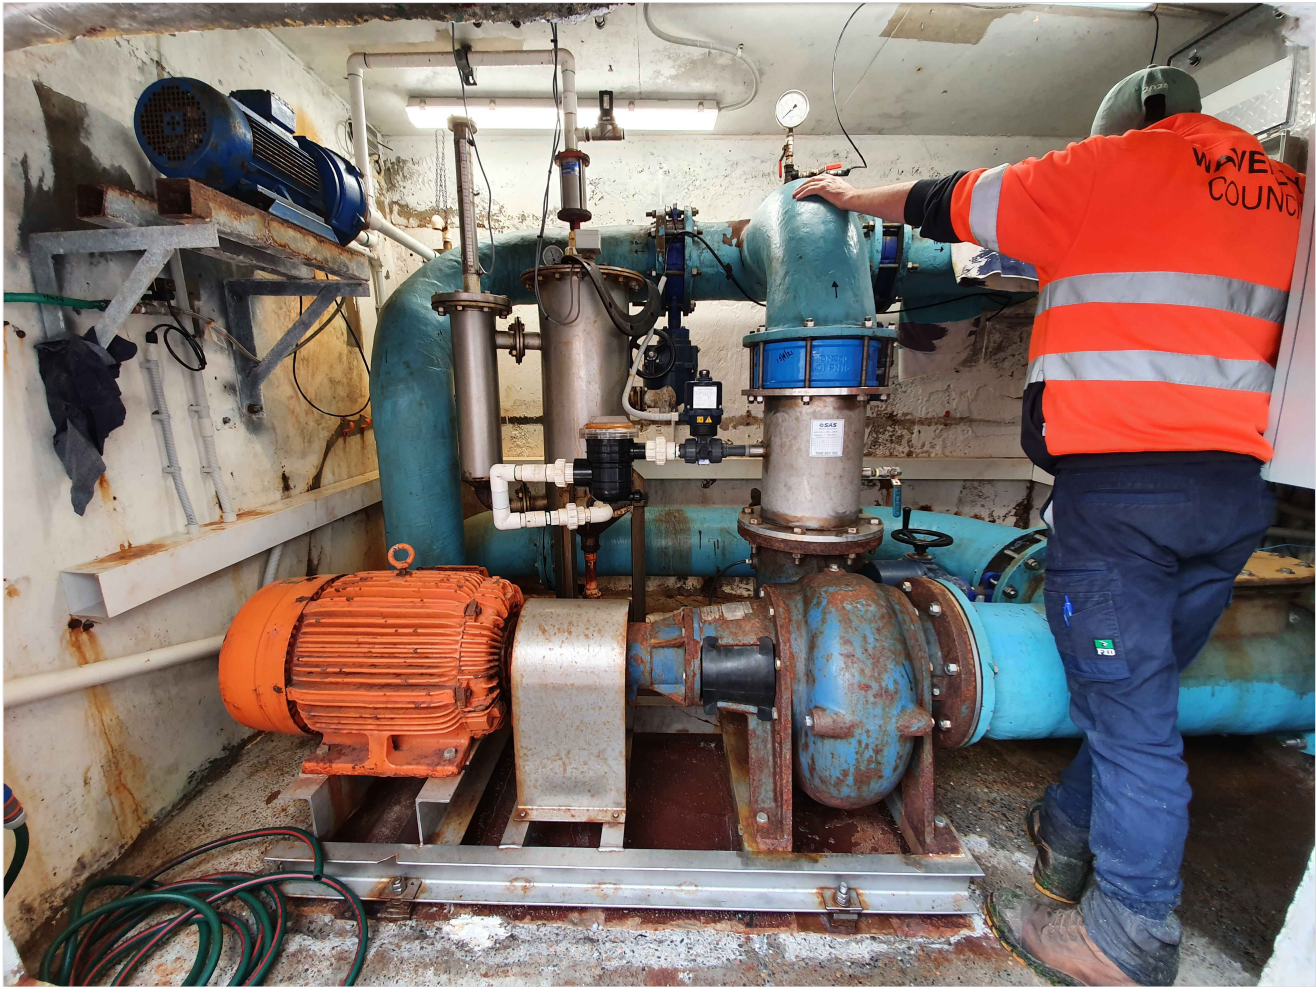
IMAGE 3 - CURRENT PUMP ARRANGEMENT

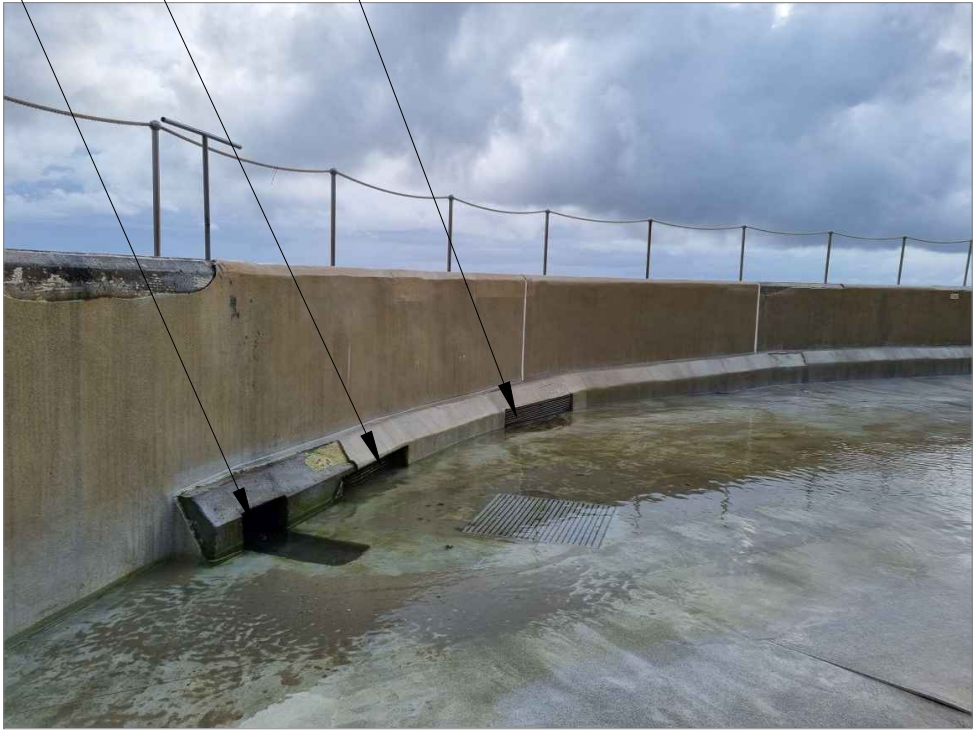
ARRANGEMENT OF BURIED/ENCASED SUCTION PIPELINE BETWEEN POOL AND PUMP HOUSE IS UNKNOWN, SHOWN INDICATIVELY.

ALL STRUCTURAL WORKS FOR THE THE NEW PUMP HOUSE MUST NOT IMPACT THE EXISTING BELOW GROUND PIPELINES

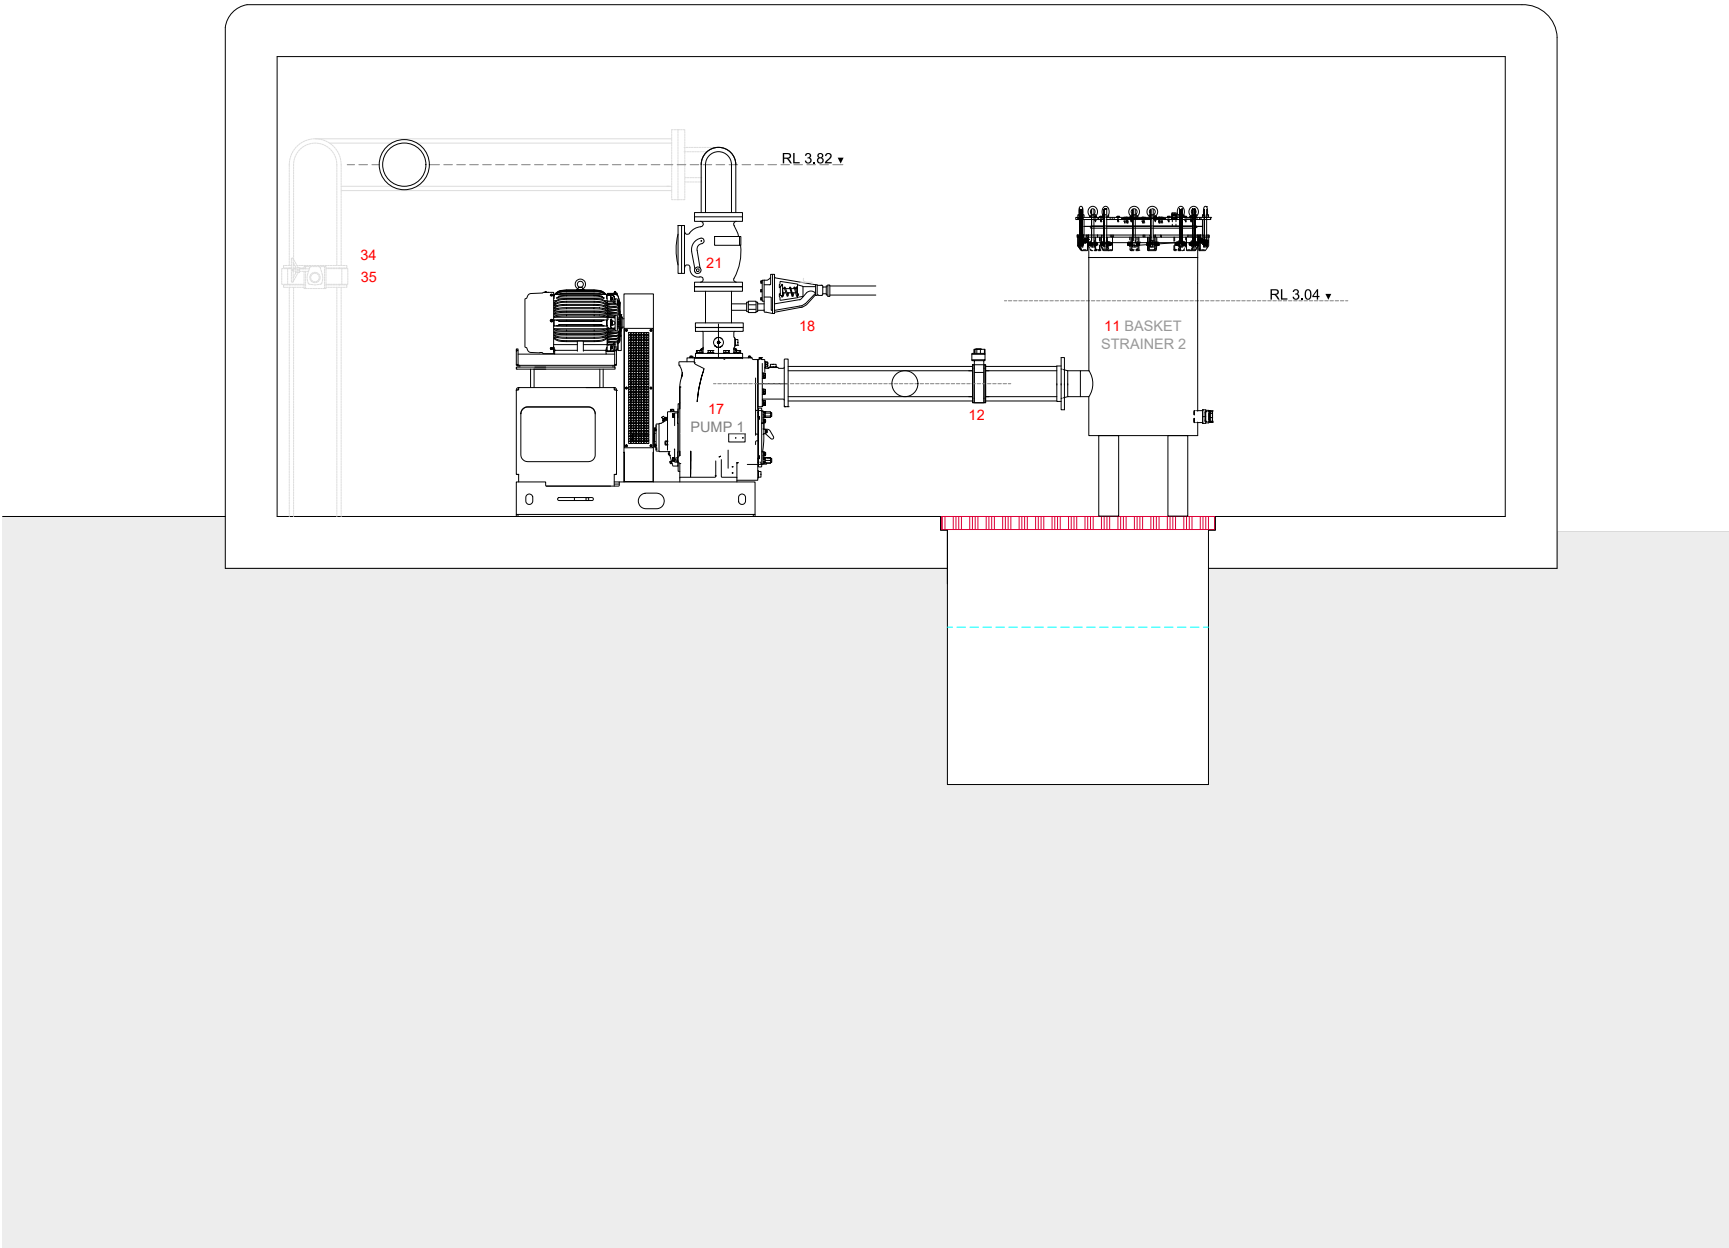
SECTION L / H35
1:20 @ A1

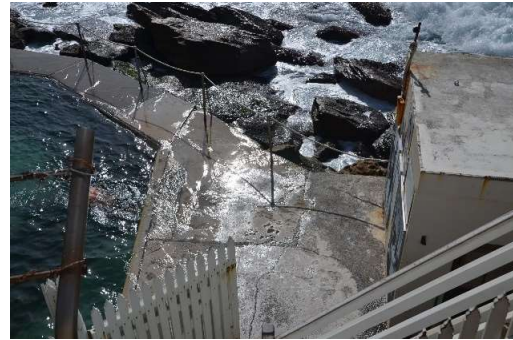
Figure S10 – The concrete apron between the ocean pool and the pumphouse.

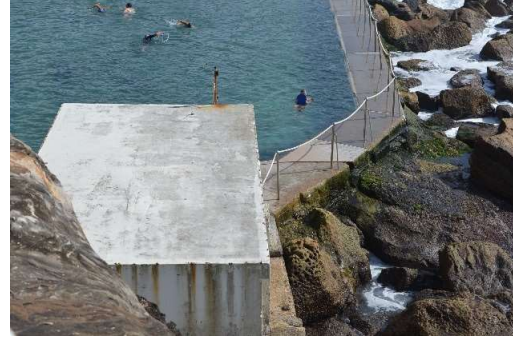
Figure S11 – The roof of the pumphouse structure seen from the east.

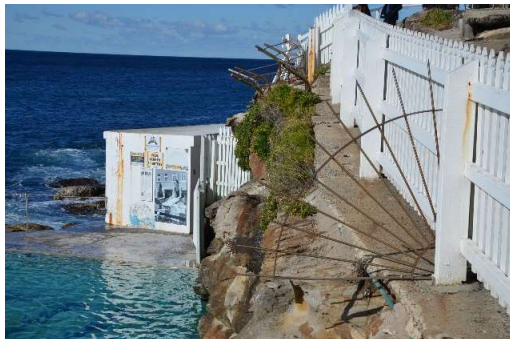
Figure S9 – The western façade of the pumphouse building facing the ocean pool. Note the various public safety accretions of occupance on the cliff face, including barbed wire, to discourage public access and jumping into the pool.

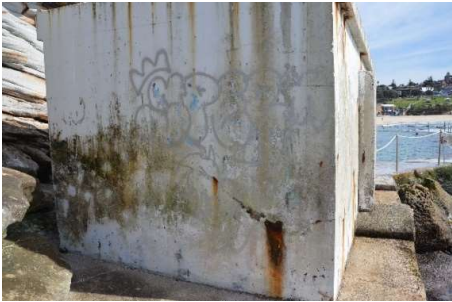
Figure S18 – The south-eastern façade of the pump house from the eastern extent of the concrete footing that supports the building.

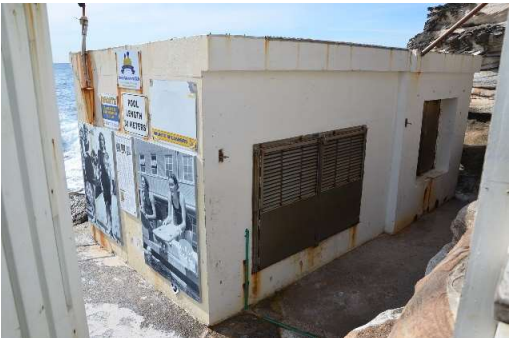
Figure S15 – The north-western and south-western façades of the pumphouse, as seen from the abutting public staircase.

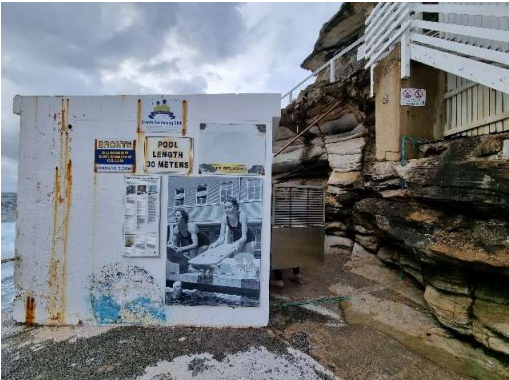
Figure S22 – Association of the pumphouse and cliff-face. Note the large concrete ‘pillar’ on the cliff-face supporting the cliff stair.

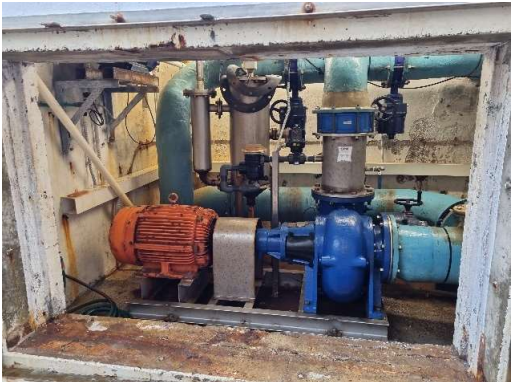
Figure S26 – Pump machinery viewed through the access doors on the south-western elevation of the pumphouse.

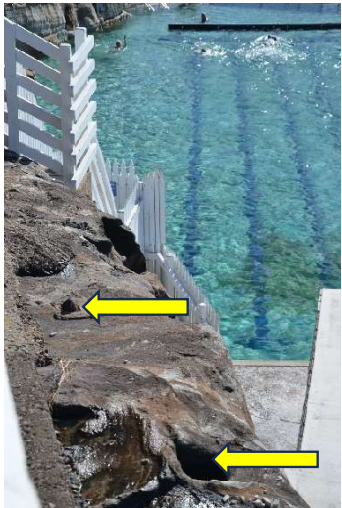
Figure S27 – Looking west from above the pumphouse, showing various relict post holes and fencing supports (arrowed) on the cliff-face above the pool.

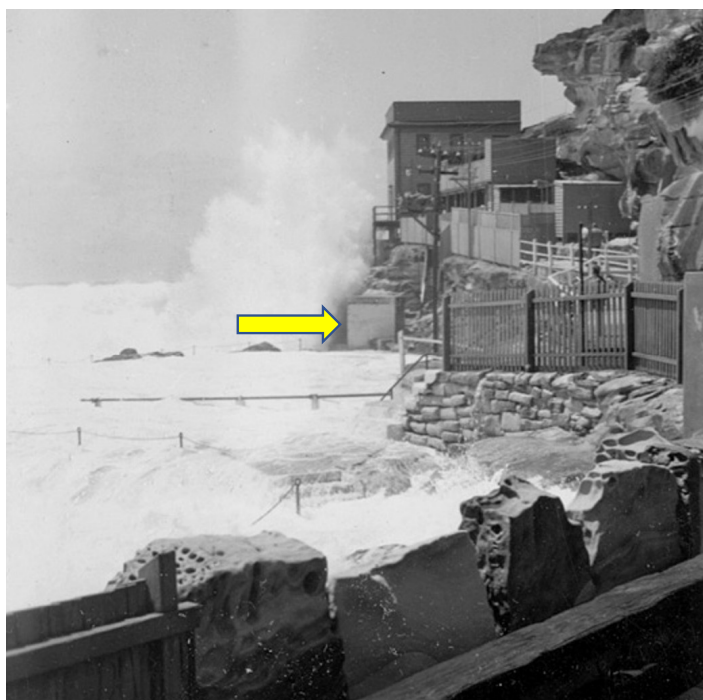
Figure H14 – Looking east over the Bronte Ocean Pool c. late 1920s showing the recently built pumphouse structure taking the brunt of heavy seas. Source: Waverley Library.

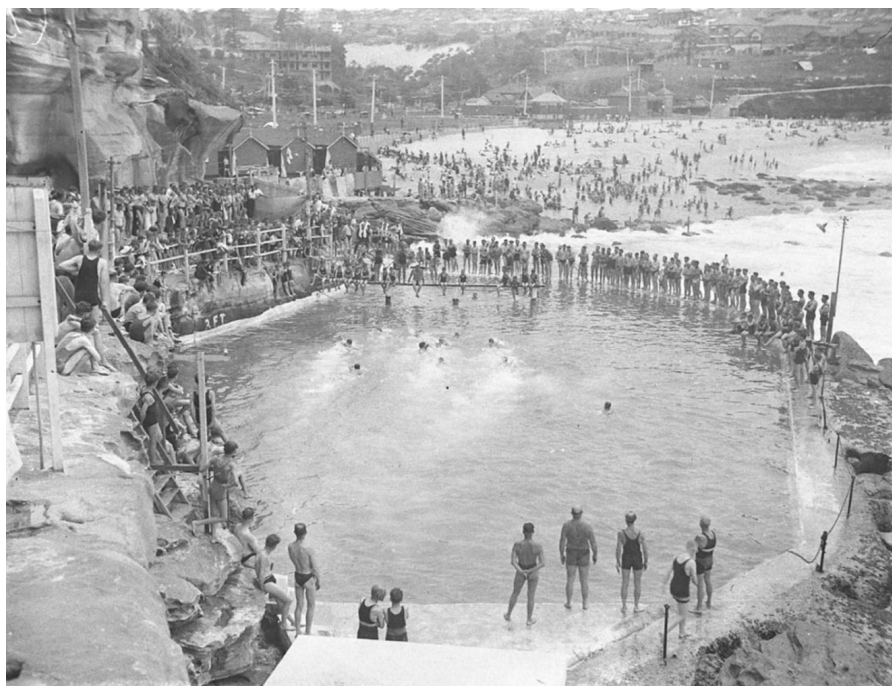
Figure H15 – c.1930 image looking west over Bronte Ocean Pool, with the roof of the recently-built pumphouse in the immediate foreground. Note the cliff ladder from the pool deck at far left. Source: State Library NSW, FL1337639.

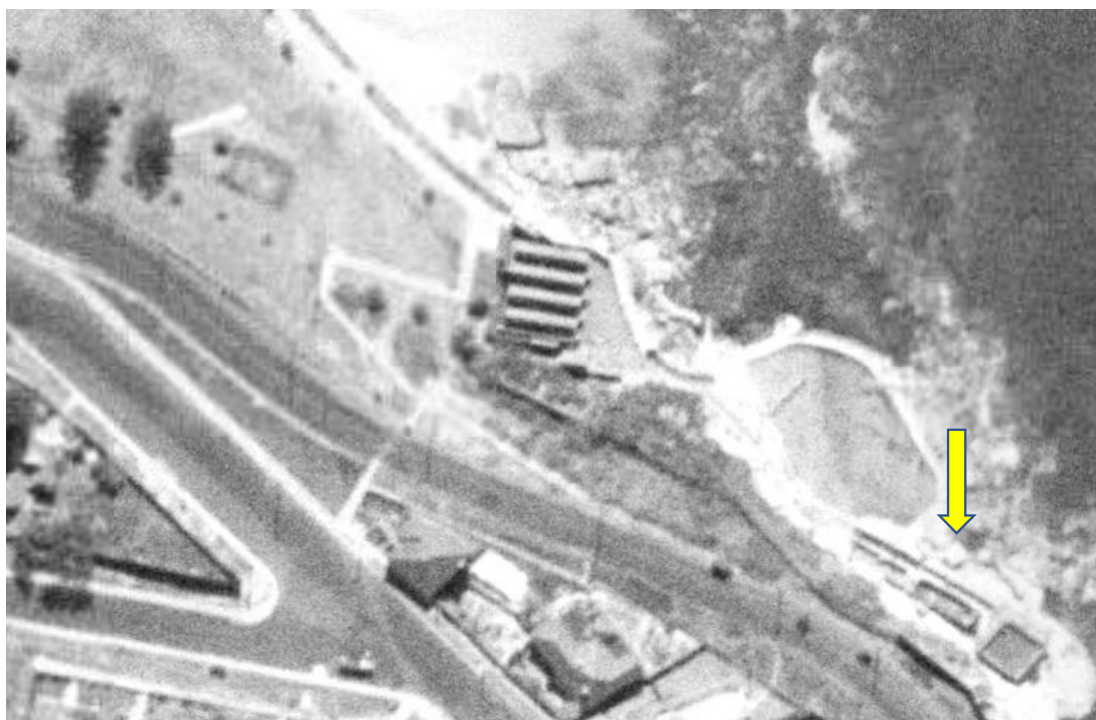
Figure H17 - 1943 aerial, showing that at that time, the swim club and change facilities components of Bronte Ocean Pool stretched across the bulk of the 'platform' at the southern end of Bronte promenade. Included in these utilitarian elements was the pool pumphouse (arrowed). Source: SIX Maps.

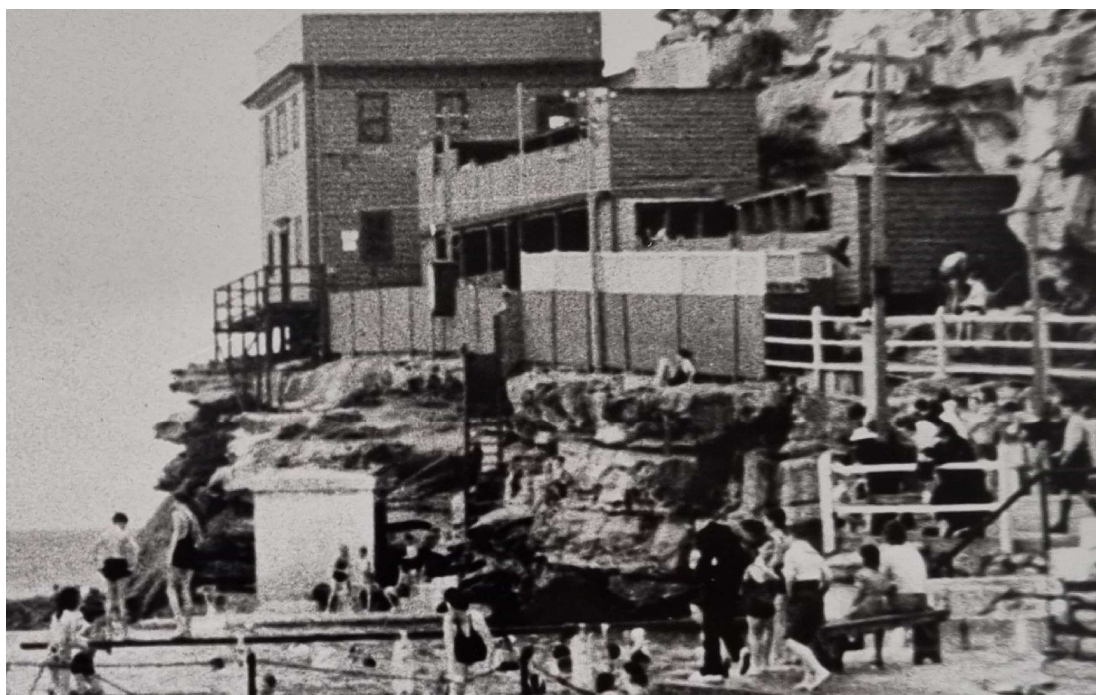
Figure H18 – Section of 1940s photograph looking east across Bronte Ocean Pool. The pumphouse can be seen at lower left, an early incarnation of the cliff stairs abutting that building also evident at the centre of this image. Source: Waverley local studies library, picture ref. 4429.

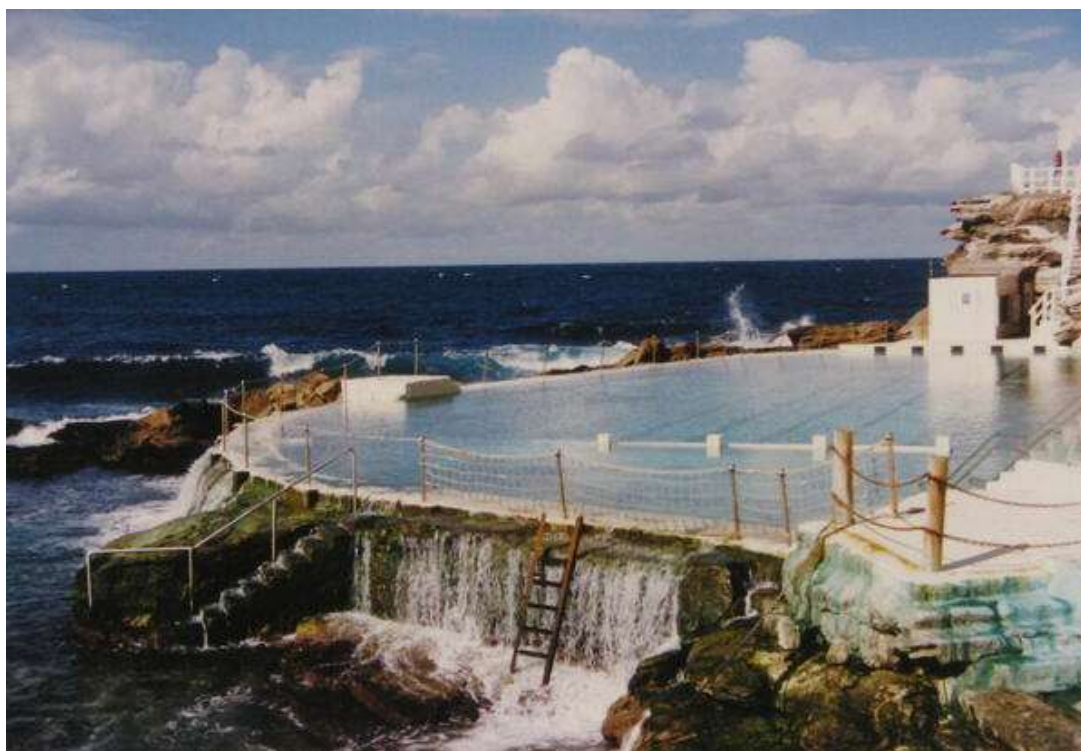
Figure H29 – A 1991 photograph across the baths, showing the pumphouse, prior to late 1990s remedial works to the structure. Source: Waverley Council.

A Wentworth Courier article from the 4th March 1998 describes health and safety concerns at Bronte Ocean Pool as a result of the pump being continually broken down. A subsequent article in the same publication from the 22nd April 1998 confirms that \$245,000 had been set aside for upgrade works at Bronte Ocean Pool. This included the replacement of the pool pump, using an overseas model. An article in the Spectator, from the 5th August 1998, suggests that the works to be carried out included not only the replacement of the pump but also the construction of a new pumphouse. This SoHI has not confirmed if indeed an entirely new pump building was built at that time. Engineering advice reviewed for this SoHI suggests that the original building was not demolished, rather an additional concrete skin being added to it.

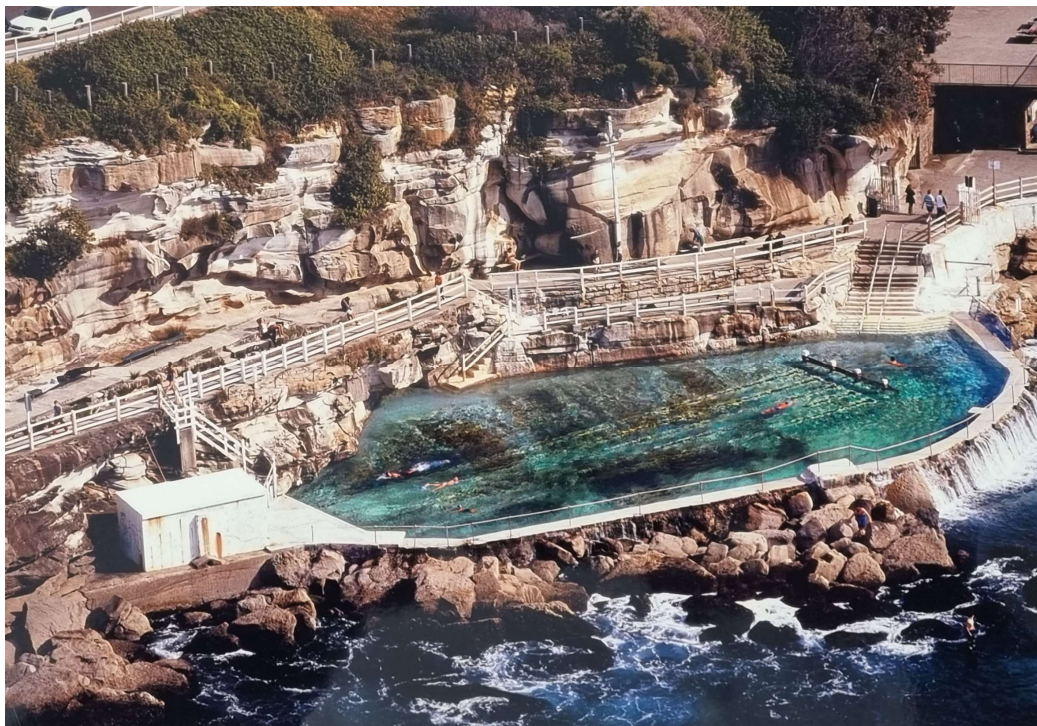
Figure H30 – Undated aerial image (c.2000s) over the ocean pool, with subject pumphouse at left.
Source: Waverley local studies library.

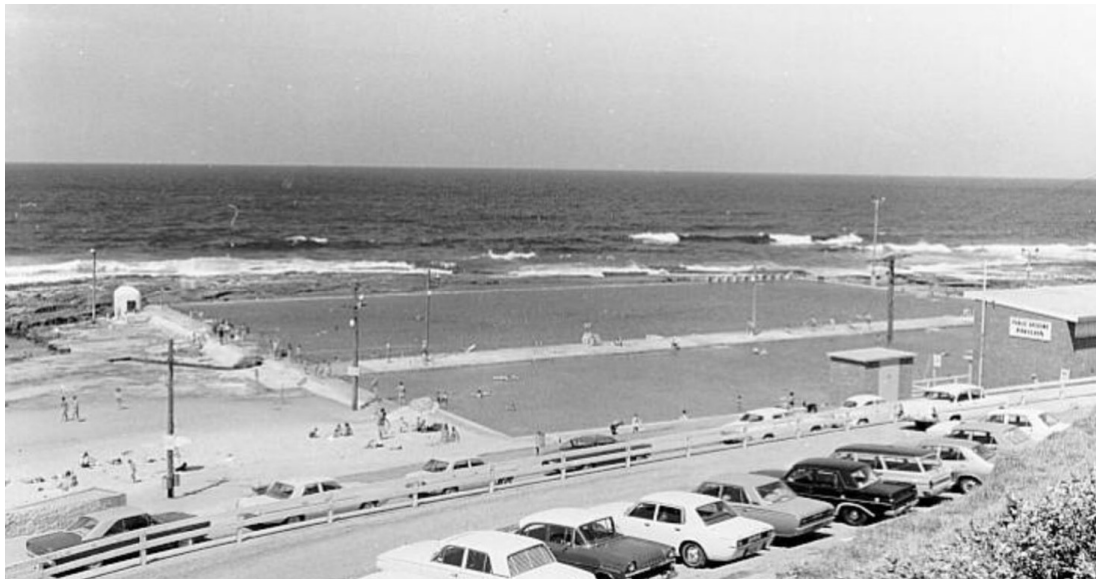
Figure H33 – Merewether Ocean Baths in 1972, several decades after construction, showing the pumphouse at left middle distance. Source: Newcastle Libraries.

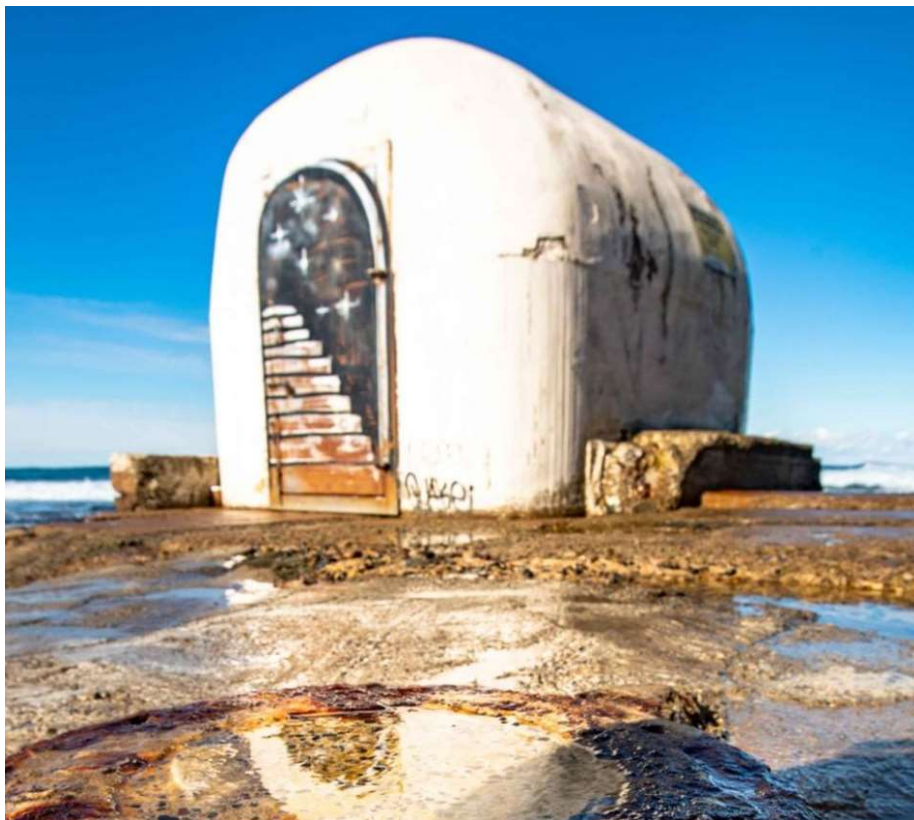
Figure H34 – Newcastle Ocean Baths pumphouse. The first pump at these baths appears to have been constructed prior to 1921 (Newcastle Sun, 16th August 1921). Source: locationscout.net
