COUNCIL MEETING

CM/7.12/25.08 Charing Cross Streetscape Upgrade - Project Update

CM/7.14/25.08 Bronte Pool - Pump House Upgrade and Pump Replacement - Project Update

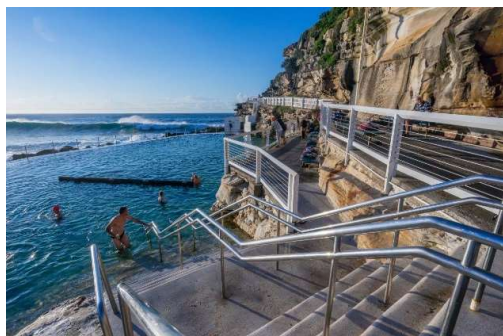
Main concrete stair at the western end of Bronte Ocean Pool. Source: Strabe.com.au

Ocean pools in NSW are serviced by a wide array of stair and ramp typologies. At Bronte Ocean Pool, there are an assortment of stair materials and forms servicing the pool from the cliff and promenade and the ocean from the pool. This includes a recent flight of broad concrete steps at the western end of the pool, concrete and sandstone block stair flights along the southern side of the pool, concrete and metal steps and metal ladder to the adjoining bogey hole and the part timber stair abutting the pumphouse. These forms and material use are representative of historic access infrastructure built to service many ocean pools in NSW.

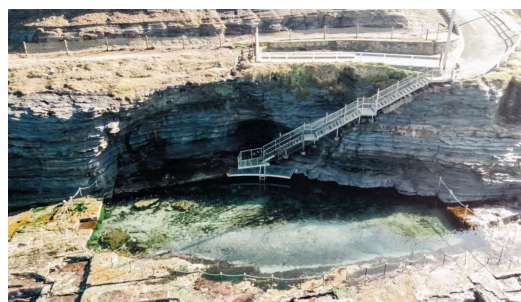
Prominent cliff staircase accessing the Newcastle Bogey Hole. Source: wanderaustralia.com.au

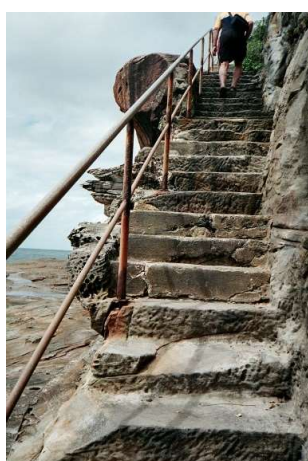
A local example of coastal pool access stairs hewn from the abutting cliff-face at Ivo Rowe Rockpool, South Coogee. Source: Flickr

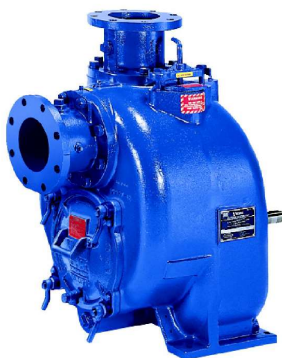
Figure P3 – The Gorman-Rupp self-priming centrifugal pump proposed for use in the new pumphouse. Source: Panov-Scott.

Due to the extent of pipework in the new pumphouse, the pump equipment would be located centrally in the new building, with a 600mm circulation zone around the perimeter. The pump and allied machinery would increase by two-fold, the overall increase in footprint of the building changing from around 19 to 25 square metres.

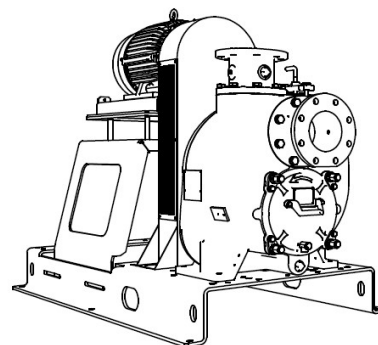
Figure P4 – Hydro Innovations vertical motor mount drawing showing the proposed pump in the foreground. Source: Panov-Scott.

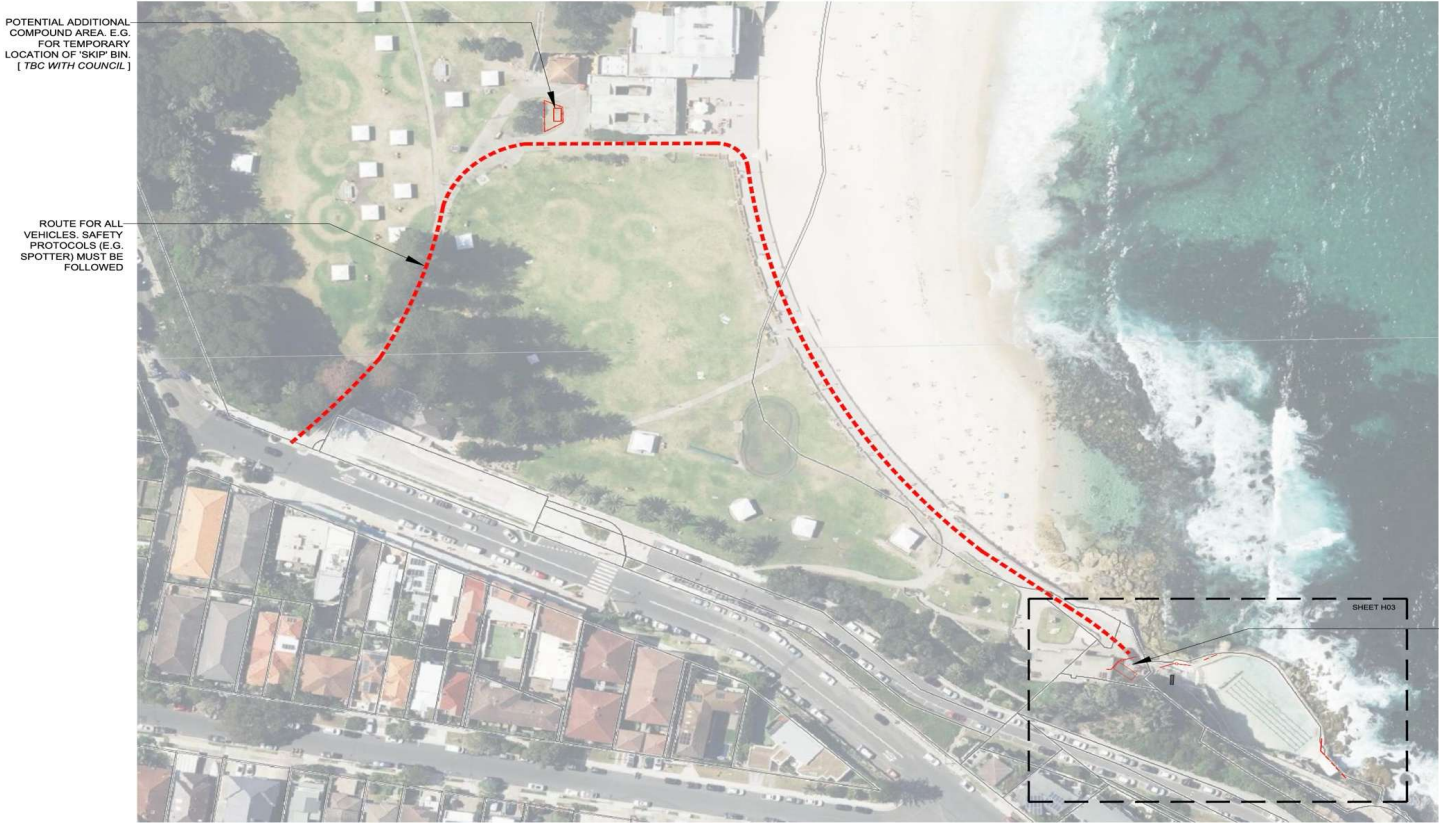
Figure 3 Site vehicle access plan (Source: Civile, 2025)

Traffic and pedestrian management would be required at the site with public access restricted to the pool during construction works. Contractors are to access the site via the promenade through Bronte Park, off Bronte Road. Temporary fencing and establishment of ancillary/storage/compound facilities would be set up within a suitable location within or near the site (to be determined by Council) to ensure the safety of construction personnel and the public and to minimise impacts to surrounding areas of Bronte Park. An indicative site vehicle access plan with potential compound area is shown in Figure 3 and a site management plan is provided in Figure 4.

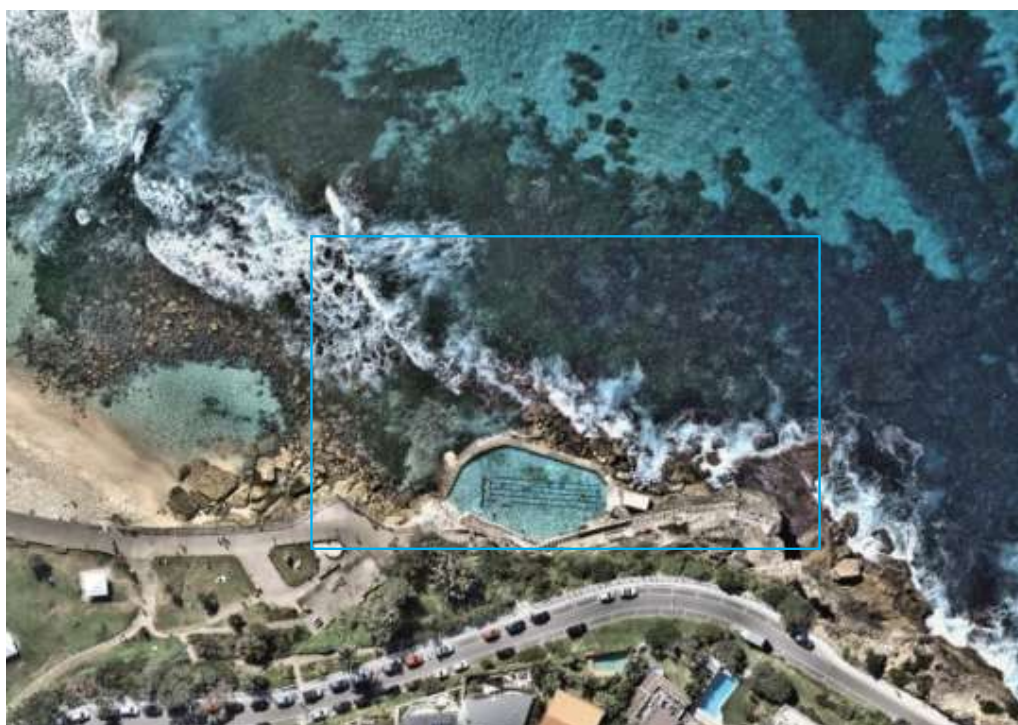
Figure 9 Approximate extent of the habitat field survey (blue) (Source: Nearmap 2025)

A field survey was undertaken on the 27 April 2023 via snorkel and site walkover. The survey was undertaken around mid-tide between the hours of 11 am and 1 pm. Conditions were fine and sunny with light winds. Moderate with some large swells affecting the site at times and restricting access to the area immediately adjacent to the pumphouse outlet. The survey was undertaken within the area shown in Figure 9 and aimed to:
